# PROPERTY INSPECTION REPORT

**246 Second St, Your Town, CA, 91355**

**Inspector: Garrett Martell CMI**

**Date of Inspection: 10/25/2022**

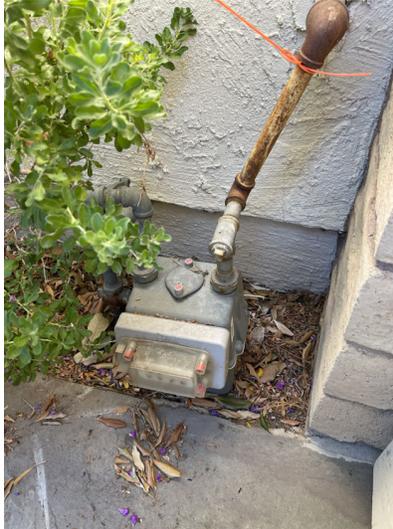
There are areas of rusty gas piping on the property.

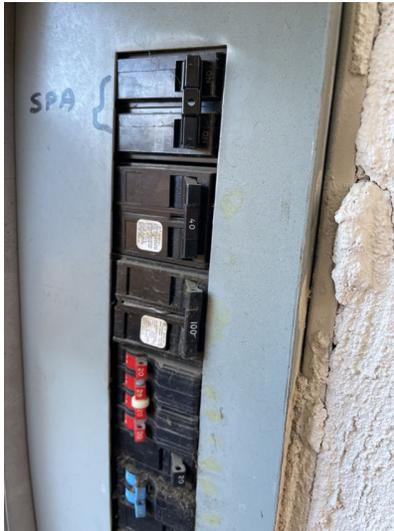
There is 100 amps for this building from the main panel.

The amount of amperage for this main electrical panel is lower than current standards and can sometimes be considered too low for a house of this size. Though this is apparently functional for the current homeowners, the low power may not be suitable for a new homeowner and their needs. It is noted that power usage will vary from household to household and that it cannot be determined in a general visual inspection whether the amount of amperage will be suitable or not.

The main electrical panel is full of circuit breakers, there is not much room in it for additional circuits if these were required. It is advised to consult with an electrician if more circuits are anticipated.

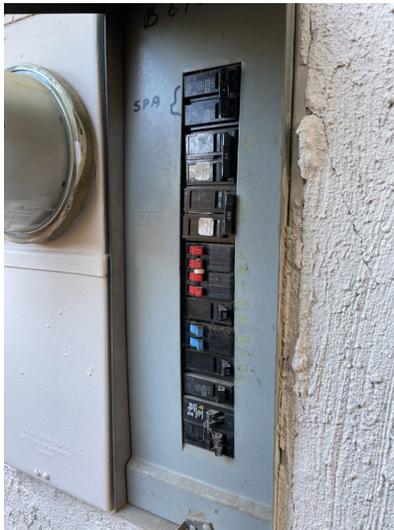
This is an older main electric panel. As it gets older it may be found that breakers will become faulty and need replacement. An electrician may recommend replacement at this time.

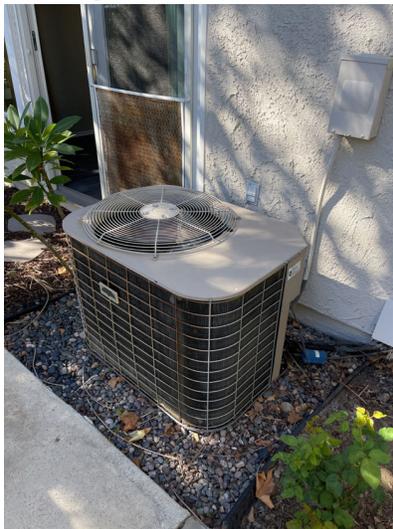
The refrigerant lines have damaged insulation on them. The insulation should be repaired to improve efficiency. This is usually not an expensive repair.

The air conditioning system is older and aged. Though it was working at time of inspection, regular maintenance will be needed to keep this system working as efficiently as possible.

The condenser is currently charged with the now discontinued R22 gas. As the supply dwindles, it will be coming increasingly more expensive to service this part of the cooling system. A licensed HVAC contractor should be consulted on this.

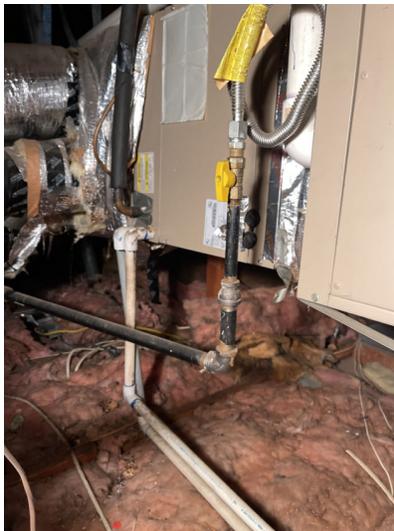
There is no condensate drain pan installed. The condensate drain pan catches excess water that did not make it into the condensate line or, the overflow if the condensate lines stop working properly. It also makes sure the water is safely disposed of outside the home.

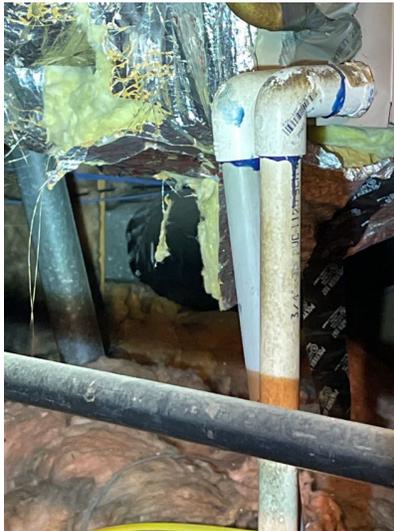
There are damaged areas of duct insulation in areas.

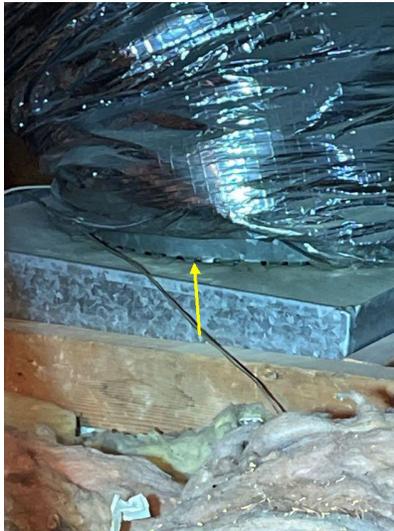
This system is drawing its "return air" from the attic. It appears the ducting has become loose around this area, leaving a small opening where I can be pulling air in from the attic. This should be sealed.

potential air coming from attic space

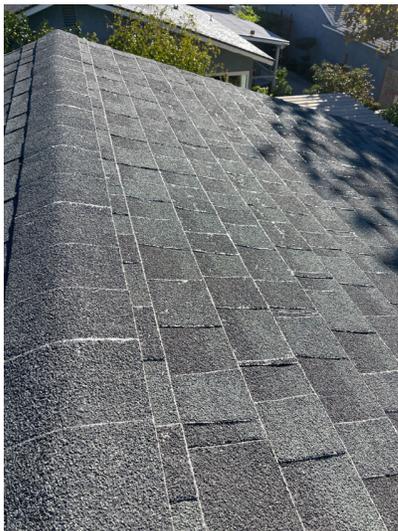
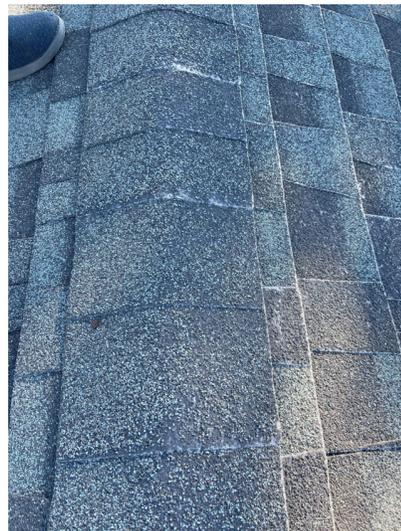
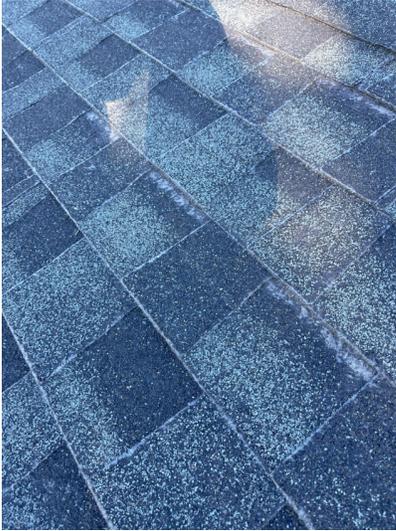
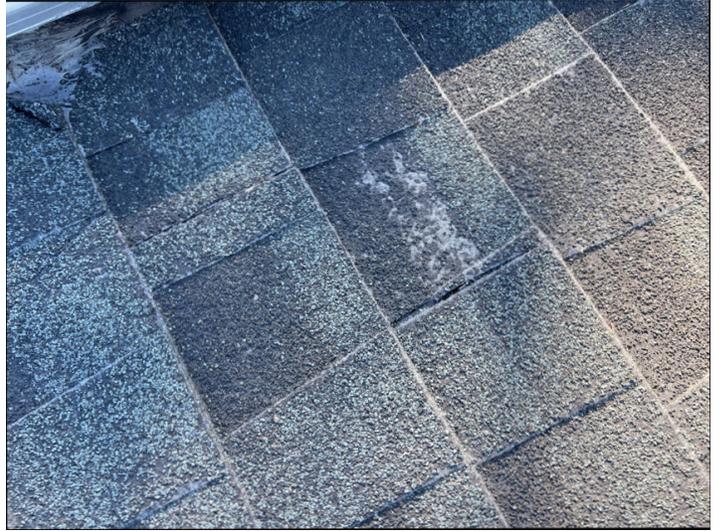
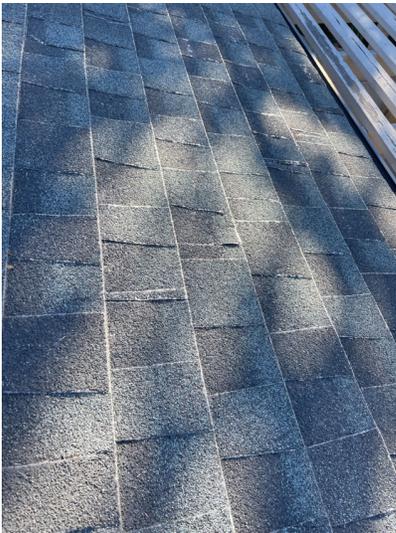
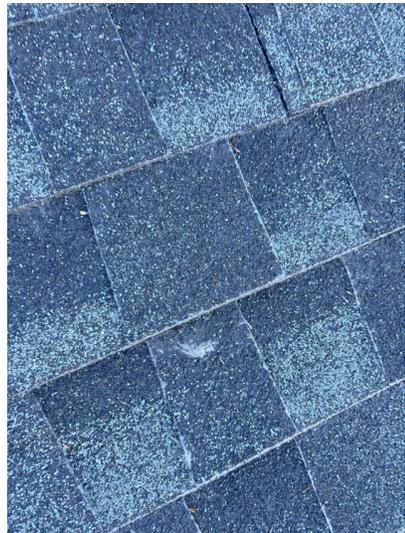
The nails heads are exposed on the roof surface. Not only will this allow them to rust, but it is a potential leak hazard. This is generally considered a poor and unreliable installation method.

**The composition shingles are older, deteriorating, and losing their surface granules.**

**The ridge caps installed at the peak of the roof are starting to crack and will need eventual replacement**

**Notable deterioration was found in areas across the roof covering that may be wind related**

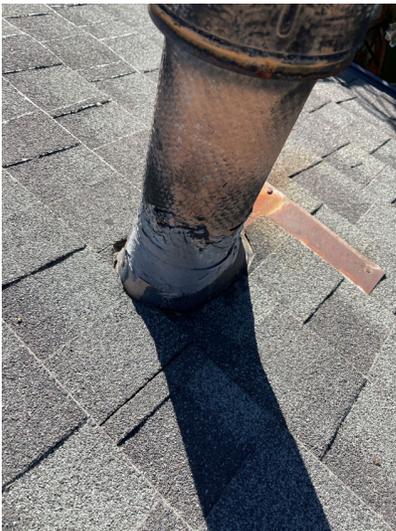
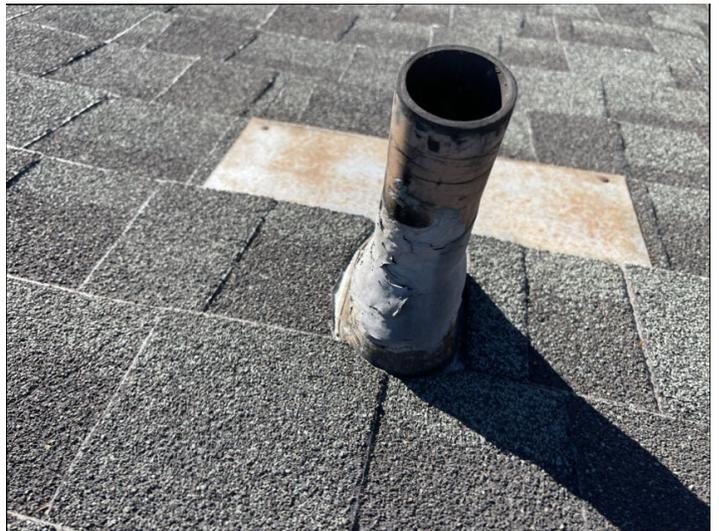
There are penetrations through the roof that are going to require a higher level of ongoing maintenance, and should be closely monitored.

The flashings have been covered over with mastic, which means these have potentially leaked in the past. This is a temporary solution and will require regular ongoing maintenance to help ensure moisture doesn't enter the roof / attic system at this point.

The flashings have been covered over with mastic, this usually means these have potentially leaked in the past. Mastic over time dries out and begins to crack which means the seal has been broken. This is a temporary solution and will require regular ongoing maintenance to help ensure moisture doesn't enter the roof / attic system at this point.

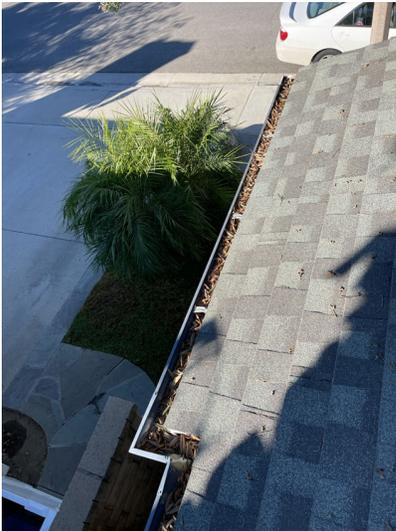
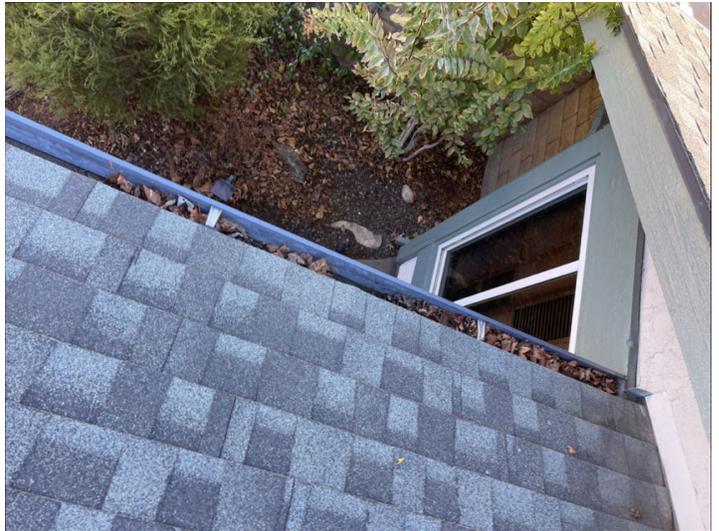
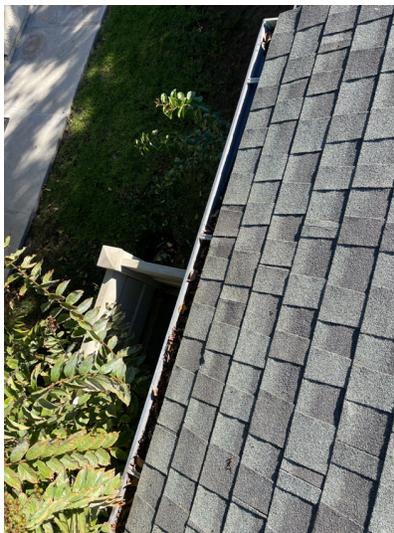
**There are areas where the gutter system is filled with debris which should be cleaned out for improved efficiency of this system. This includes all accumulated roof debris on the roof itself.**

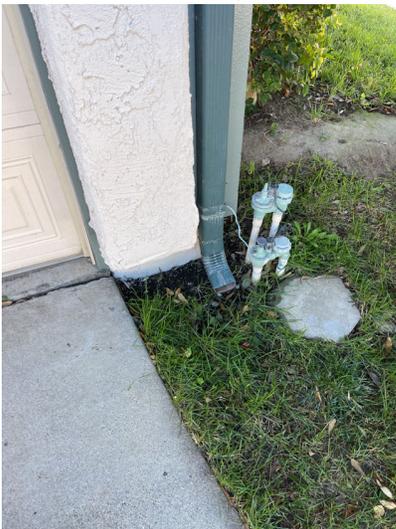
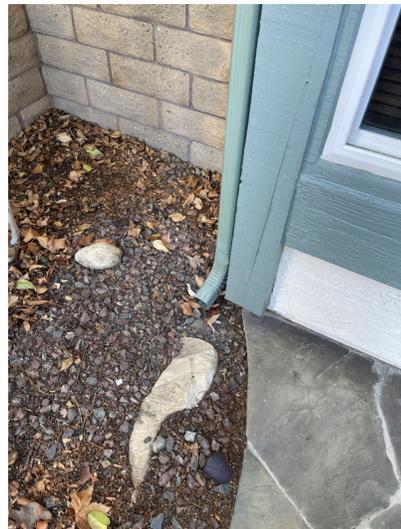
The downspouts do not all route the water away from the building but instead deposit it next to the structure which can cause problems to the foundation over time.

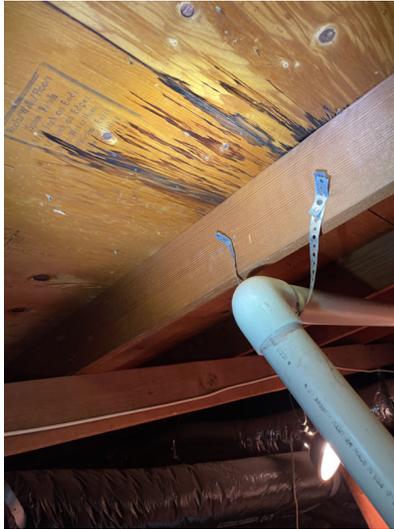
There are areas of moisture stains on the framing lumber. These are common in attics and may indicate past leaks.

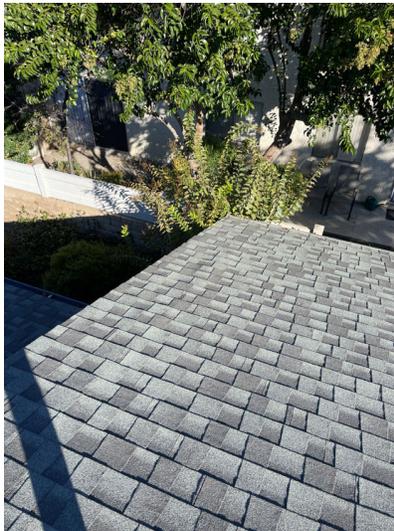
There are branches laying or rubbing against the roofing material. These need to be trimmed back or removed to prevent damage from occurring to the roof.

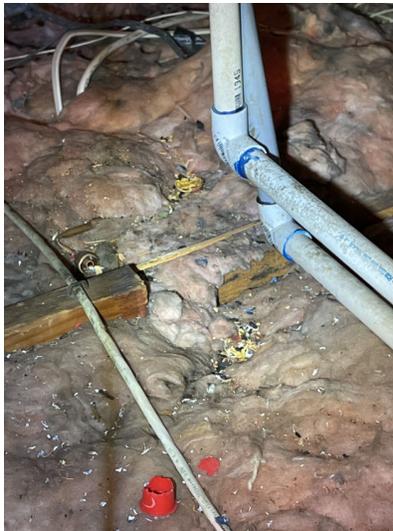
Rodent droppings were observed in the attic. It is advised to have a pest control specialist examine the structure and property to determine the presence of any infestation. They will also have recommendations on the possible treatments.

rodent droppings

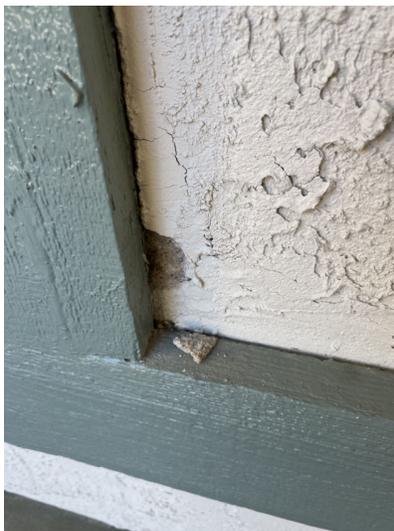
There is typical cracking in the exterior stucco wall covering.

There are damaged areas of the stucco wall covering that will need repair.

The exteriors of the building appear to have had recent work such as patching and painting. Though this appears serviceable at this time, the original condition the wall covering was in prior to this work is unknown.

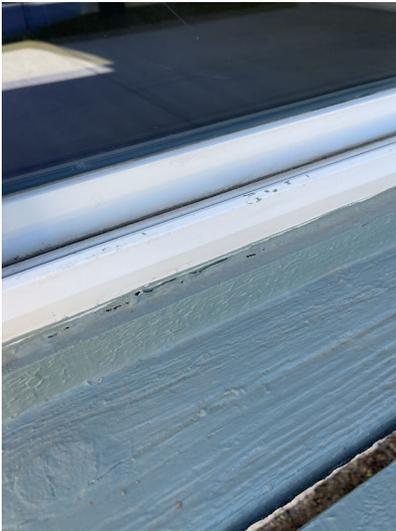
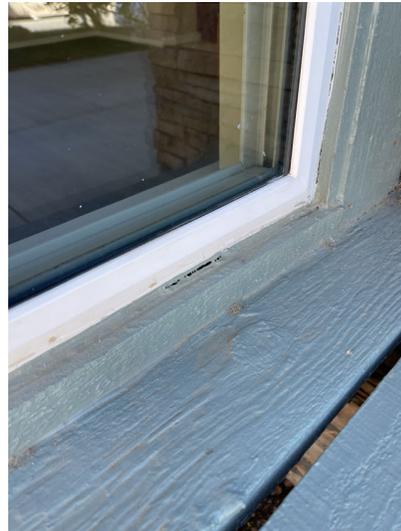
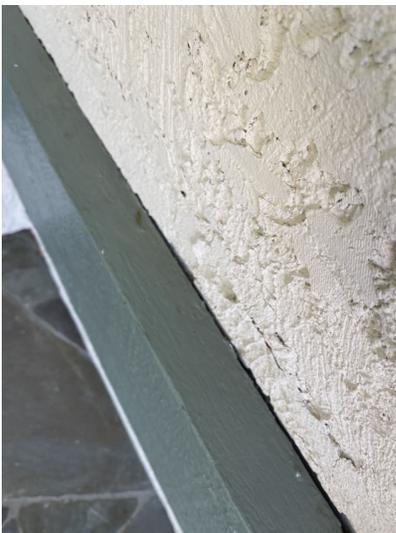
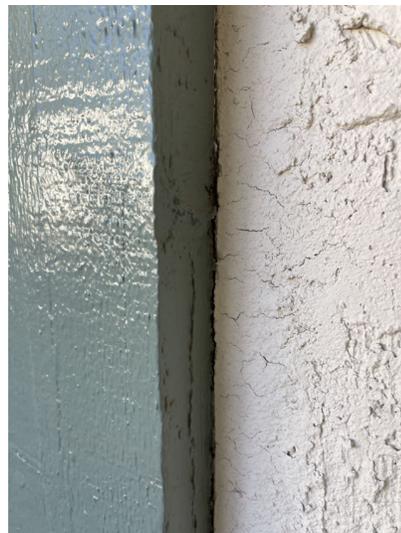
The trim does not appear to be sealed to the window frame properly.

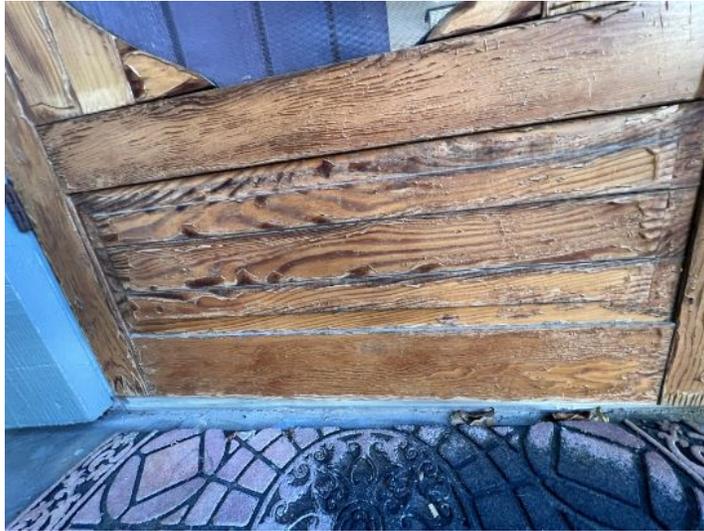
Front screen door

Front wooden screen door is deteriorated and is stained.

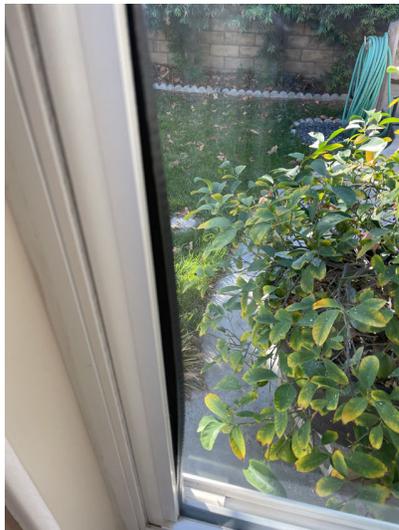
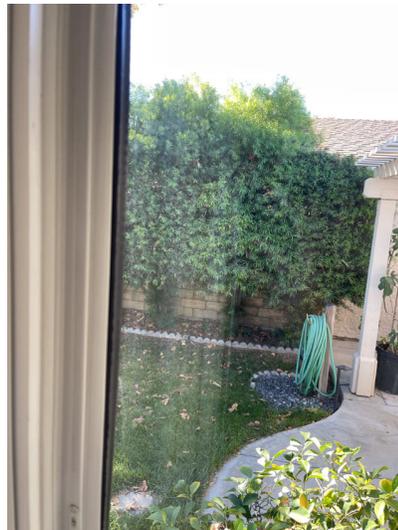
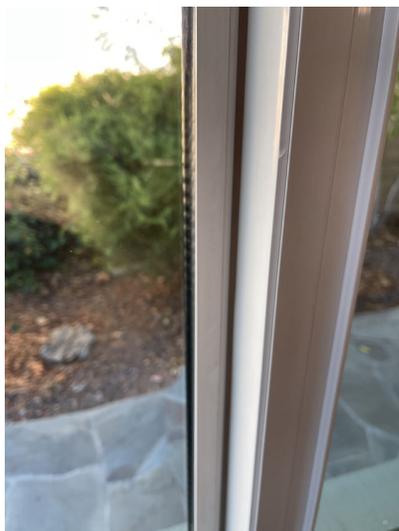
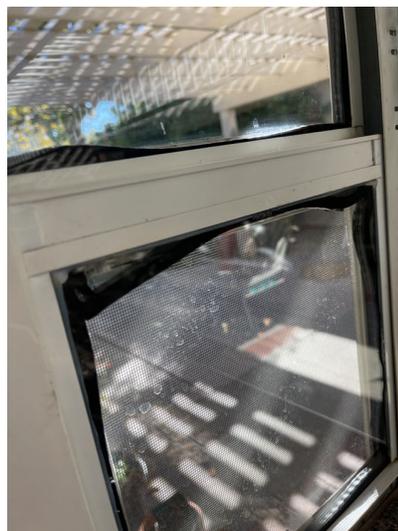
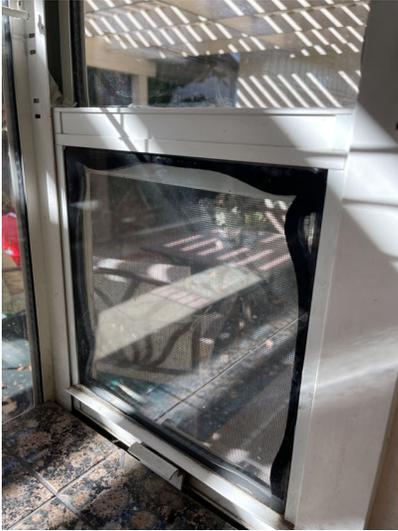
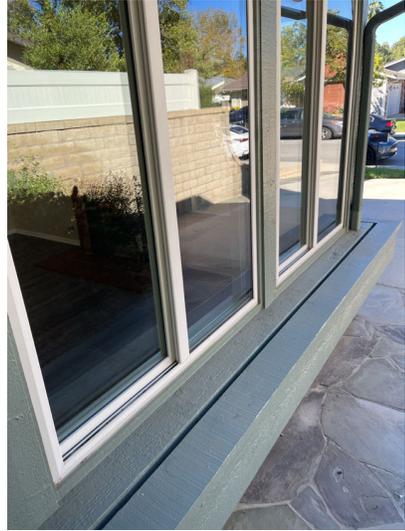
There are seals that are getting appear to be getting close to failing. This is able to be seen due to the fact that the black sealant material is pulling in words to the center of the panes. There is no telling when this will happen, but the process appears to have begun.

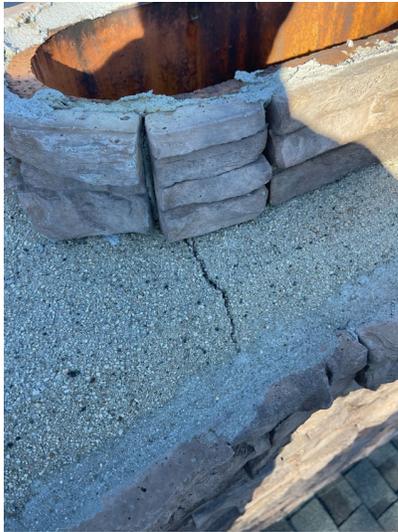
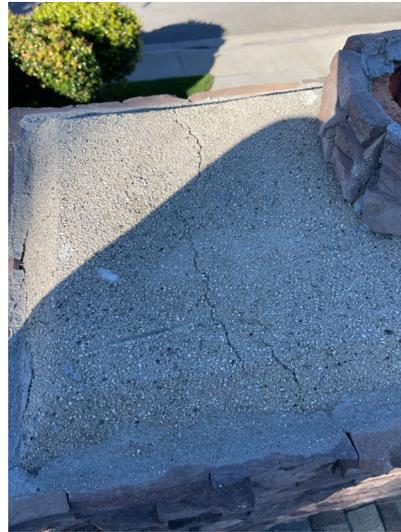
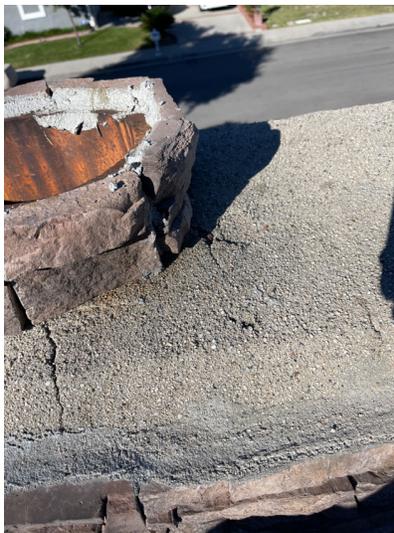
There are cracks in the concrete chimney crown that will need repair.

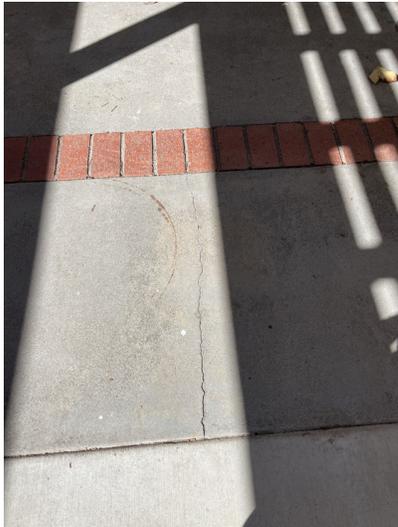
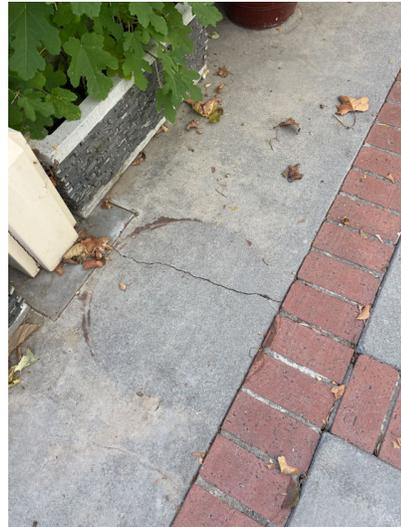
There are cracks and shifted areas of concrete that are typical for the age and type of construction.

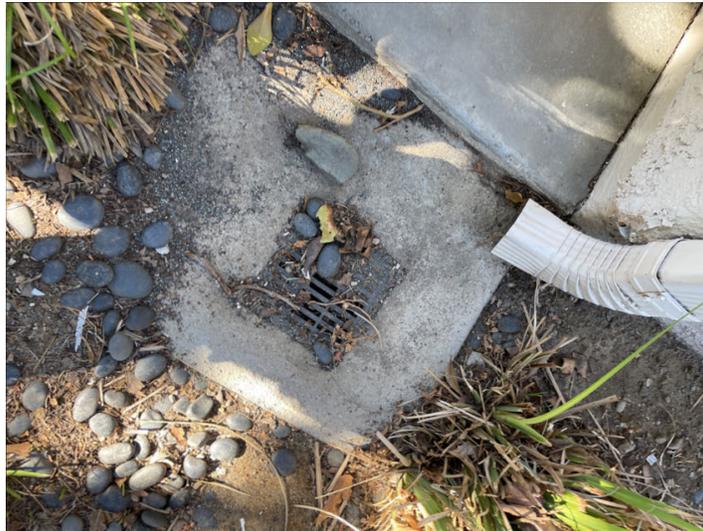
There is debris visible in the below grade drains. These need to be cleaned and tested, so they function as they should.

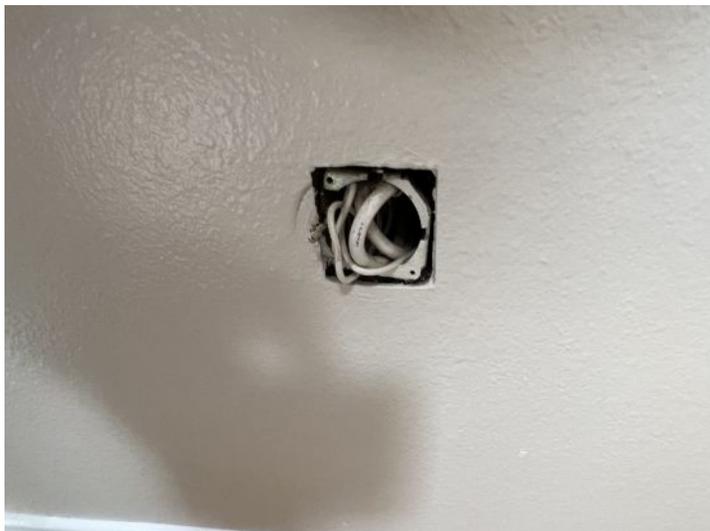
There are areas of possible asbestos textured ceiling in the building. It is unknown if this is the type that contains asbestos. It would have to be sampled and analyzed in a lab to determine if this is asbestos.

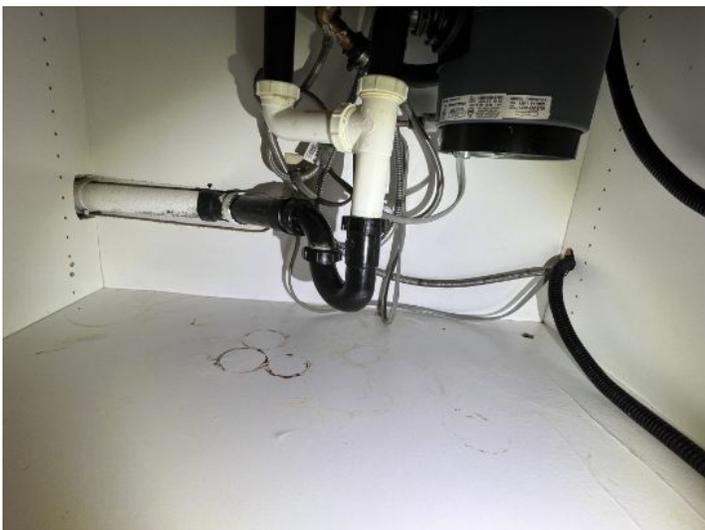
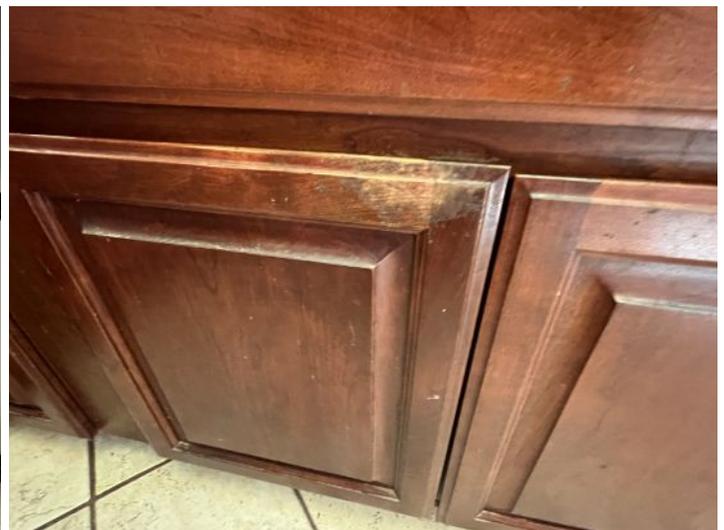
The cabinet area below the sink has damage/deterioration which appears to have been caused by moisture.

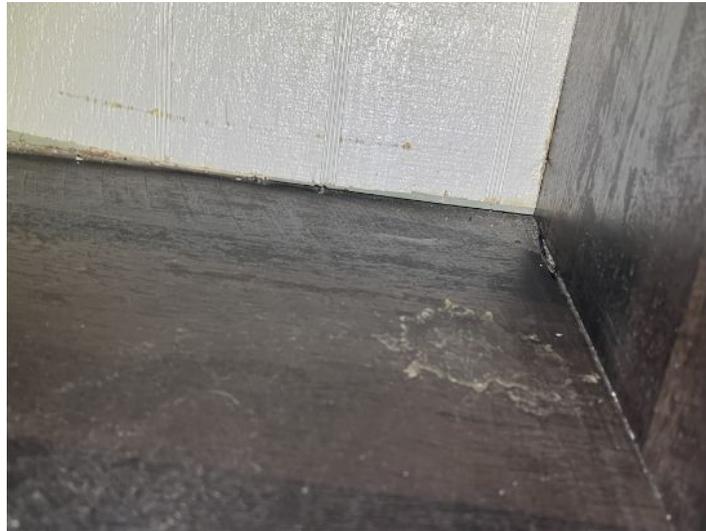
The cabinet area below the sink has damage/deterioration which appears to have been caused by moisture.

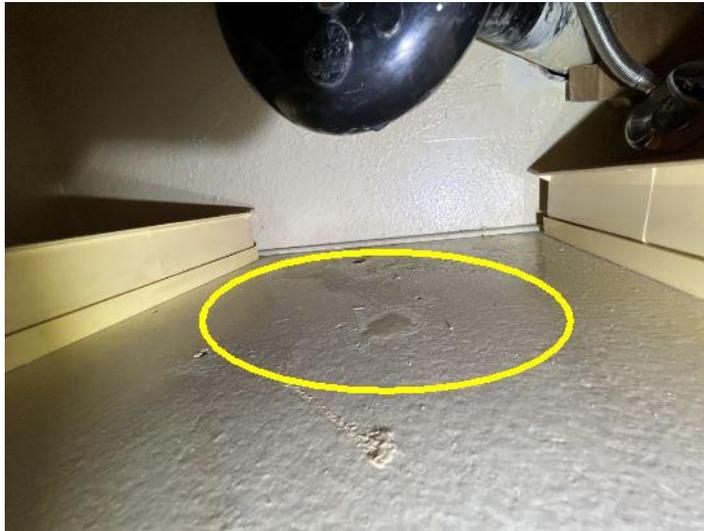
**The faucet leaks into the cabinet below.**

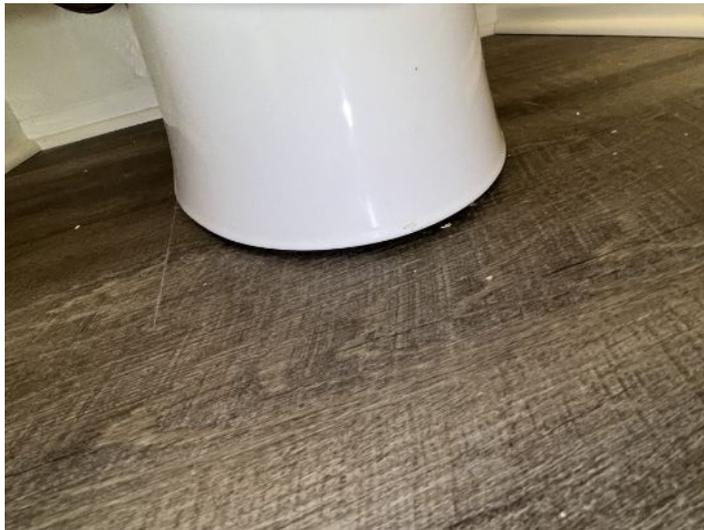
There is no visible caulk seal between the base of the toilet and the floor.

No caulk seal

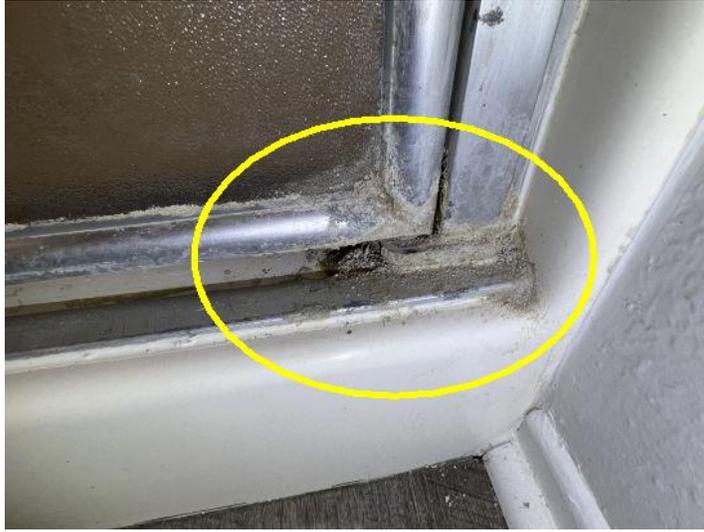
There are areas of corrosion/rust on the enclosure frame.
