PROPERTY INSPECTION REPORT

123 Anywhere St, My Town, CA,

Inspector: Garrett Martell CMI

Date of Inspection: 11/26/2022

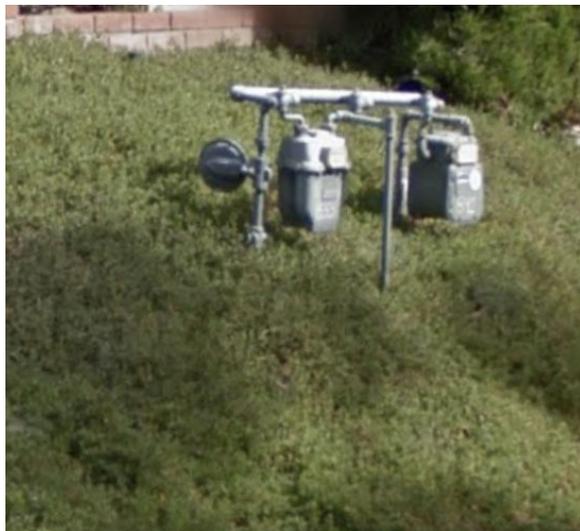
What appears to be the gas meter for this property was located at the front of the neighbors home to the left of the property being inspected. This should be verified with the seller.

located in the neighbors yard to the left

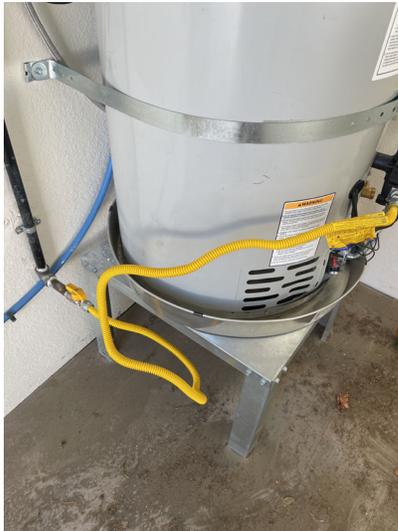
There is no sediment trap on the gas line coming into the water heater. Please see the glossary for an explanation of a Sediment Trap.

No sediment trap

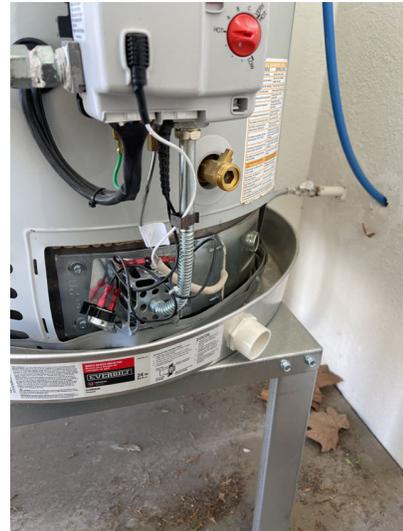
The bottom cover that is used to cover up the area where the gas goes into the combustion chamber is missing.

missing cover

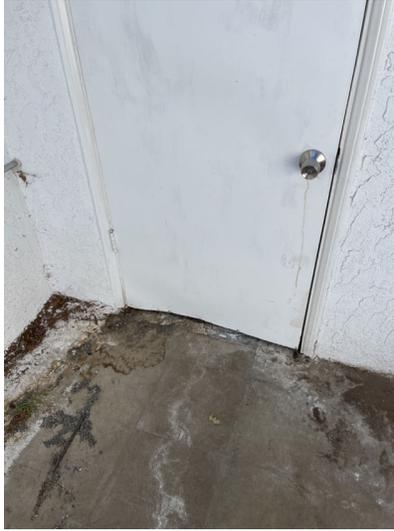
The door to the water heater closet has areas of water damage at the bottom of it. There is also no venting inside of the store to help provide **combustion air** to the water heater.

water damaged door

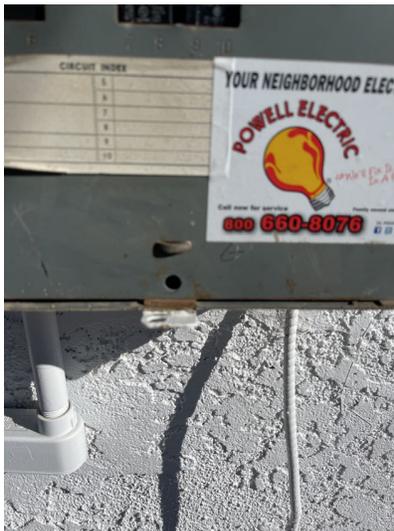
There is a missing screw on the dead front cover.

missing screw

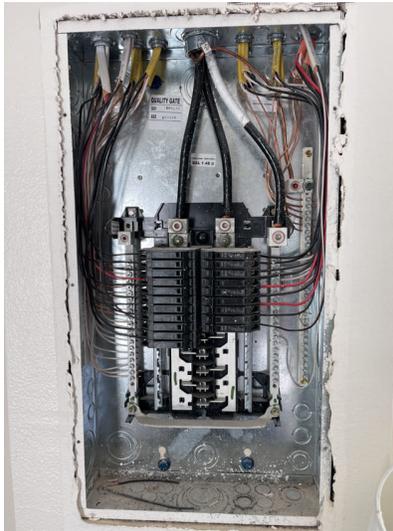
There are knock-outs missing in the sub panel leaving open spaces in the dead front cover which leaves exposed live electrical items as a result. This is an inexpensive fix to correct but should be repaired to make the panel more safe.

The circuit breakers in the sub panel are not labeled. It is not known which circuit goes with which breaker. This could pose a problem in case there is an emergency reason comes up to shut off power to a specific area of the home.

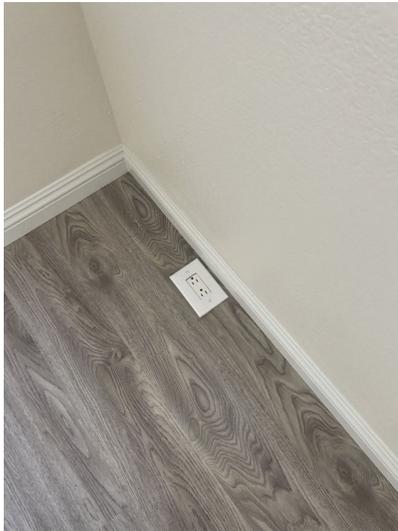
There are outlets located on the ground in areas of the home. Is outlets do not have the proper metal covers to protect them from Damage And to keep dirt and debris out of these outlets.

no proper cover plate

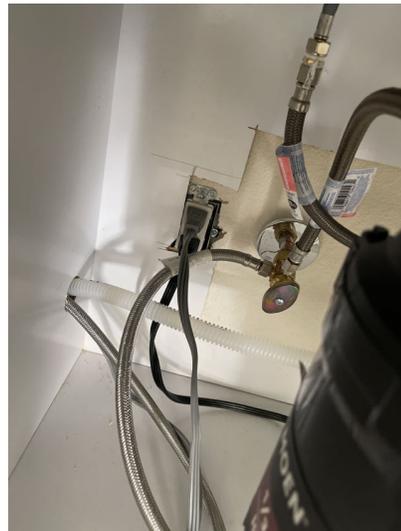
There is one or more missing cover plates in areas of the home.

Missing cover plate(s)

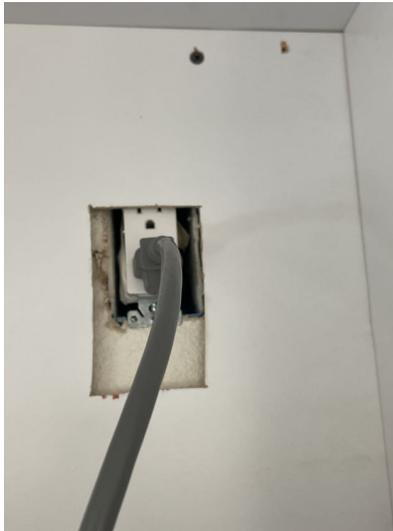
Missing cover plate(s)

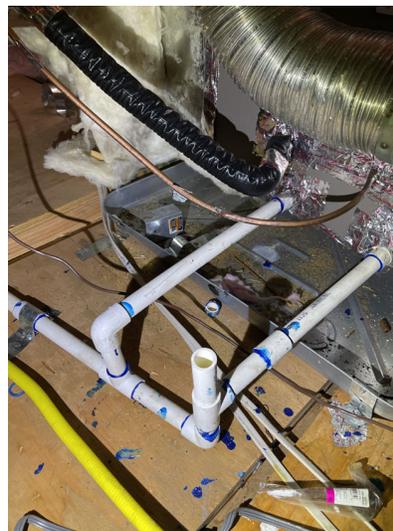
The condensate drain line does not have a proper trap installed. This should be added for improved efficiency and operation of the condensate drain line.

The primary and secondary drain lines are connected together outside the system rather than having been run separately to proper locations. This means there is no effective secondary drain line, and one should be installed for proper operation.

no trap / 1 & 2 connected

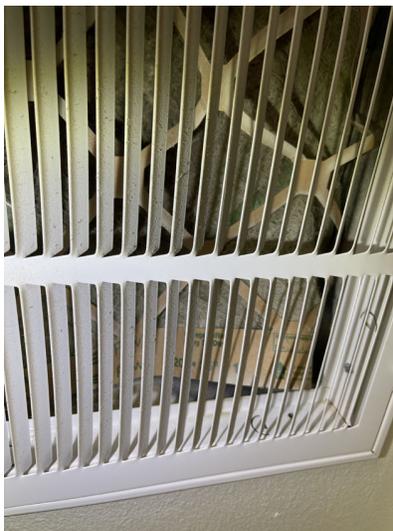
The air filter is dirty and nearing the time to replace it. This is not an expensive item, it should be changed regularly.

It appears that the air filter being used currently is too large for the opening, which is what caused the damage on the installation.

filter dirty / damaged / too big

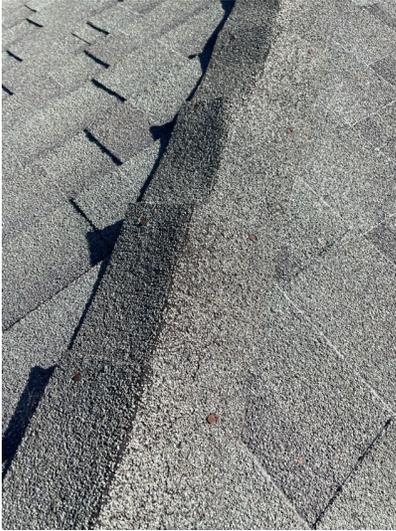
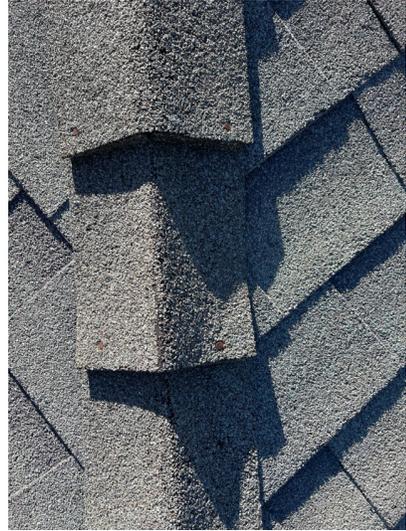
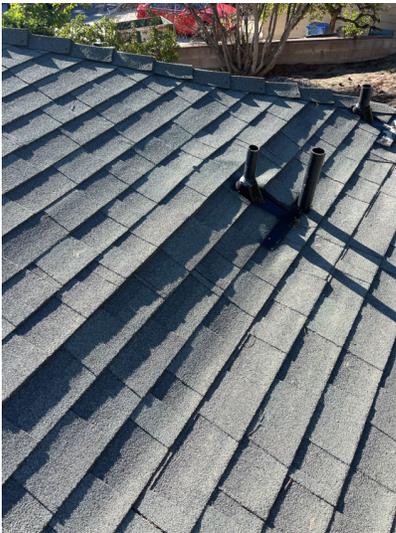
There are standard composition shingles installed over the low slope or flat roofing. The use of this material is not recommended for this location unless this is a cosmetic covering over a waterproof roofing system. Or, this roof would require two layers of roofing paper under the shingles. The roofing paper is not visible as it is installed underneath the roof covering. Otherwise, this is an unreliable roof and is prone to failure and leaking. This should be checked by a licensed roofing specialist, and the permits for this installation should be verified.

poor install

A licensed roofing contractor is being recommended to examine the roof to make all needed repairs (or replacements) to ensure a long-lasting leak free condition.

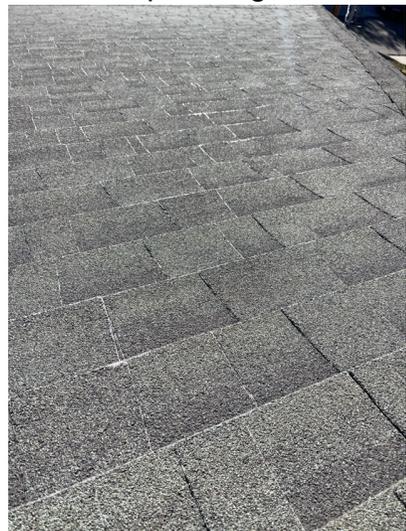
Notable deterioration was found in areas across the roof covering.

notable deterioration

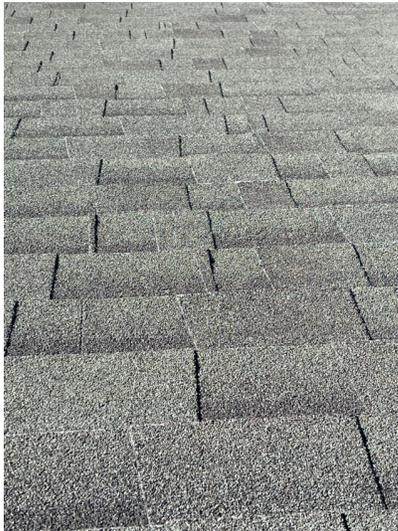
notable deterioration

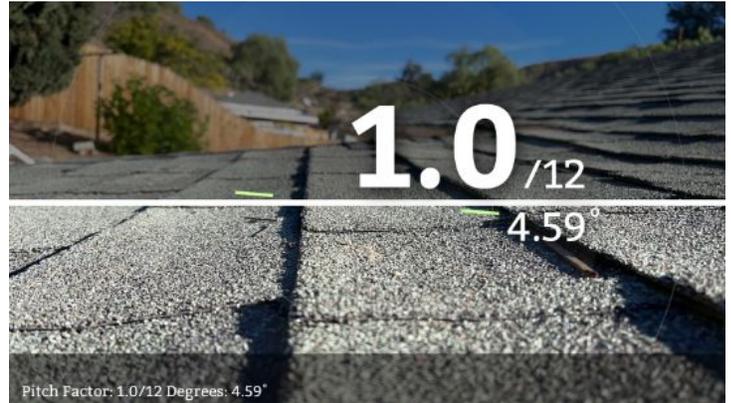
wrong slope for composition tile

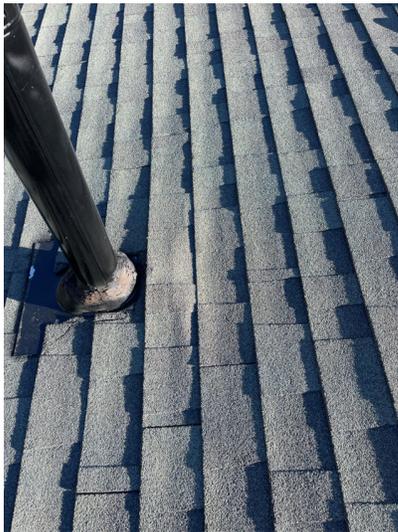
It appears the flashing around the furnace vent has not been installed properly nor was the roofing nail down properly in this area after installation.

roof covering loose around flashing

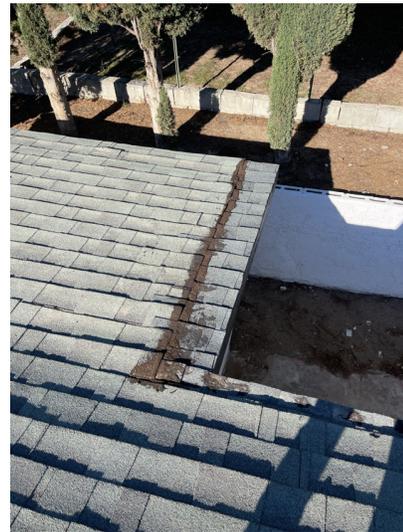
The flashings have been covered over with mastic, which means these have potentially leaked in the past. This is a temporary solution and will require regular ongoing maintenance to help ensure moisture doesn't enter the roof / attic system at this point.

civered mastic / roof patching

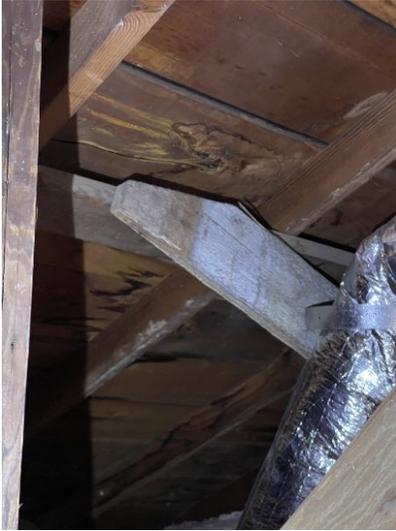
There are areas of moisture stains on the framing lumber. These are common in attics and may indicate past leaks.

Moisture staining

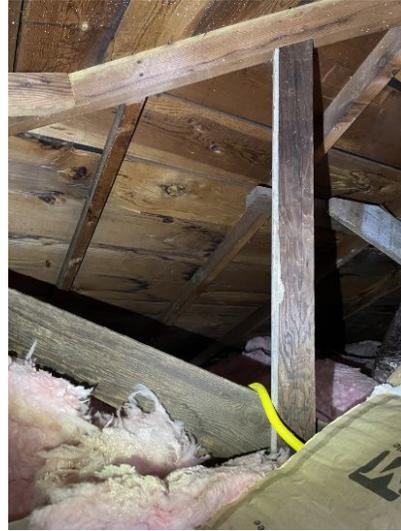
Moisture staining

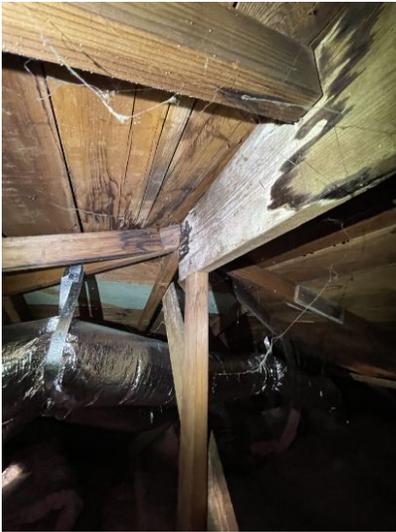
Moisture staining

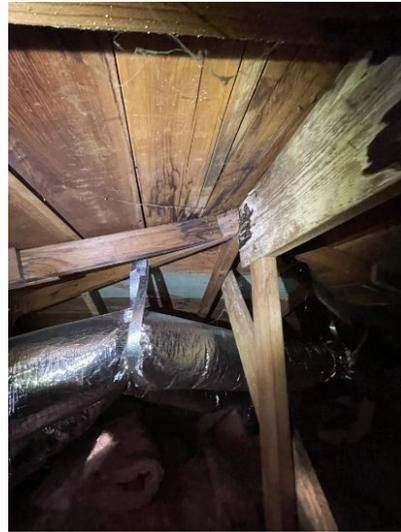
Moisture staining

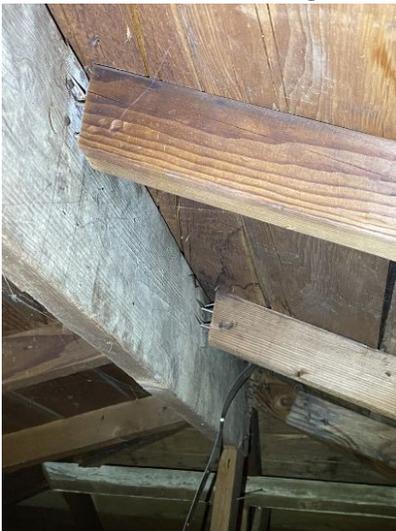
There has been some notable separation between the ridge and rafters. Further evaluation is recommended.

Ridge/rafter separation

A framer should be called to repair the roof framing

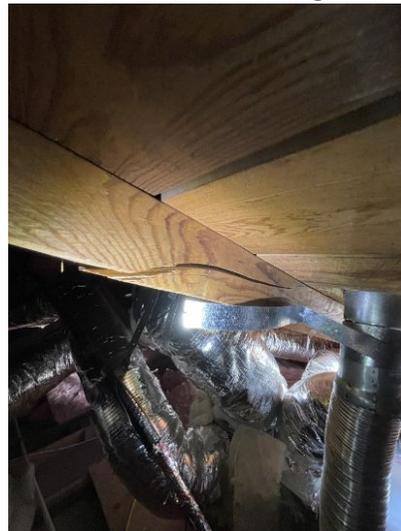
The rafters are cracked in areas which will need repair.

Rafters cracked

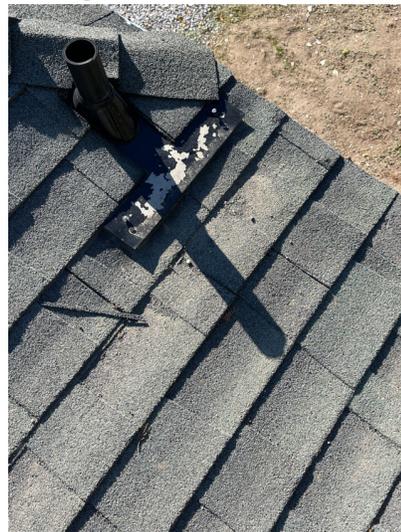
ponding

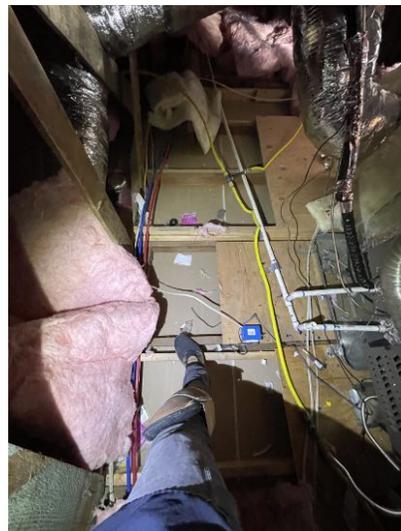
Disturbed insulation

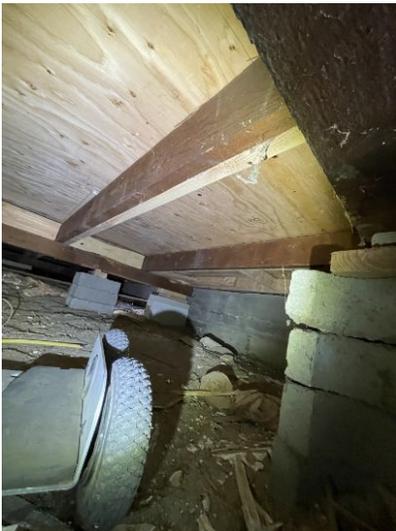
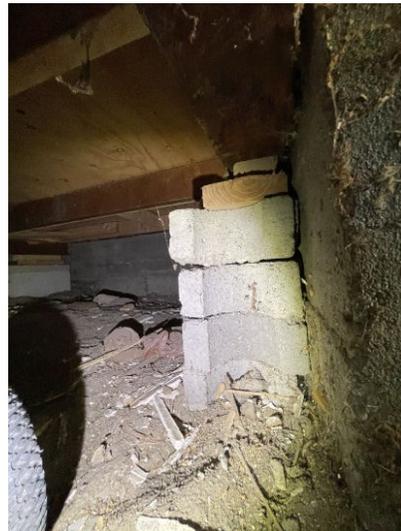
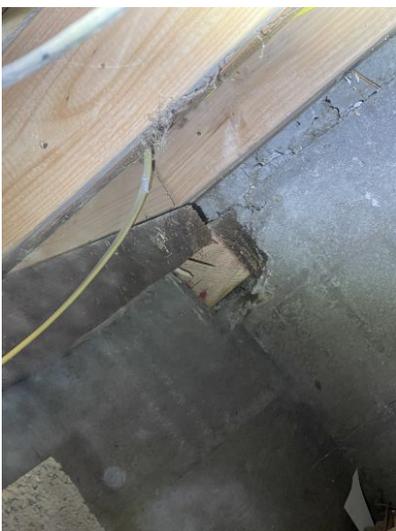
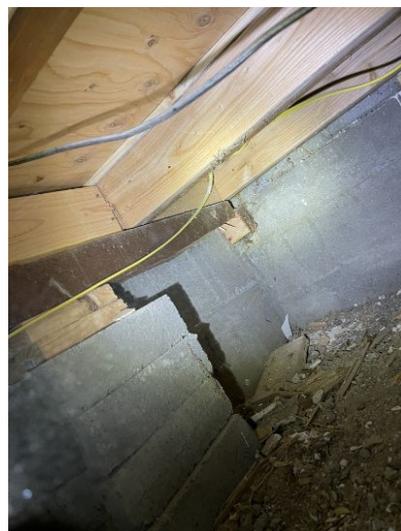
Areas of the framing will need repair.

A number of pieces of wood such as shims are being used in place of a single support post in areas. These tend to fall out during seismic activity and are not properly attached to each other or the framing of the structure.

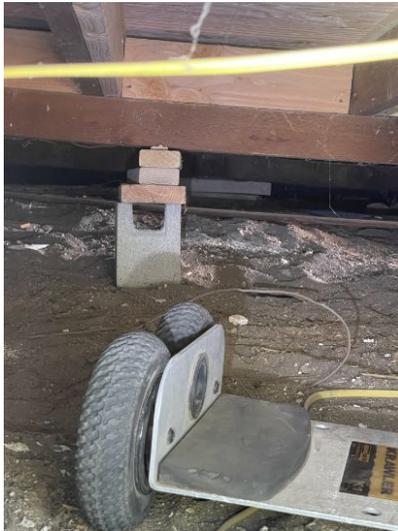
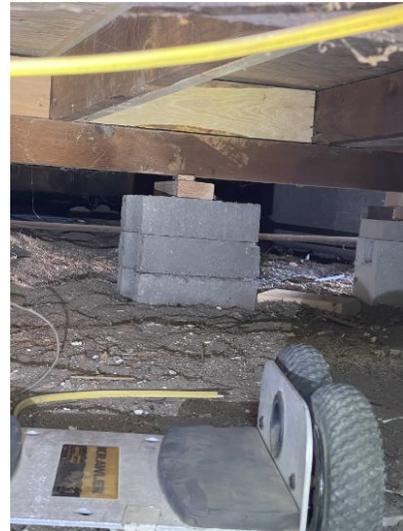
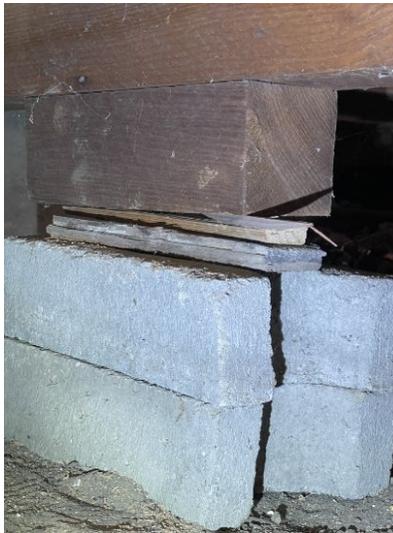
Some posts have shifted over time.

Instead of there being proper posts and piers, there are what appeared to be patio pavers and cement block placed on the dirt with shims of wood

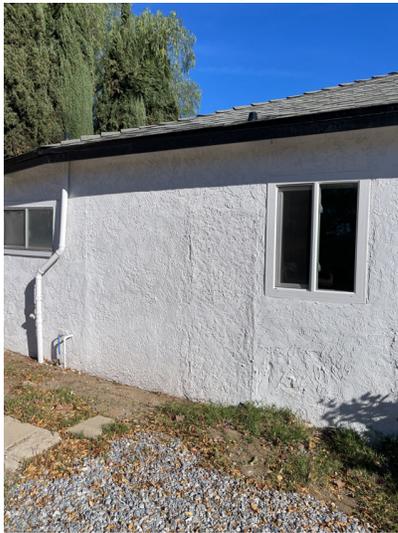
There are areas of patching and painting from over the years.

patching

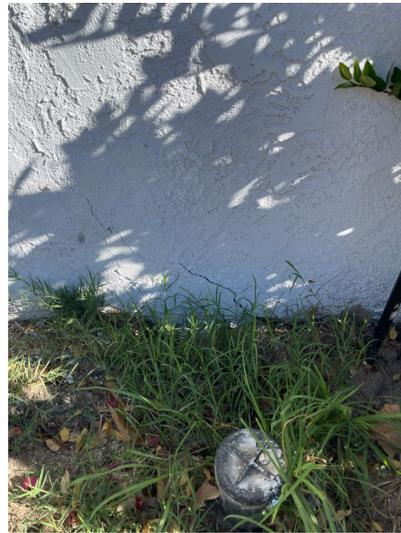
There is larger cracking in the exterior stucco wall covering. Repairs are needed to ensure there is no water intrusion.

large cracking

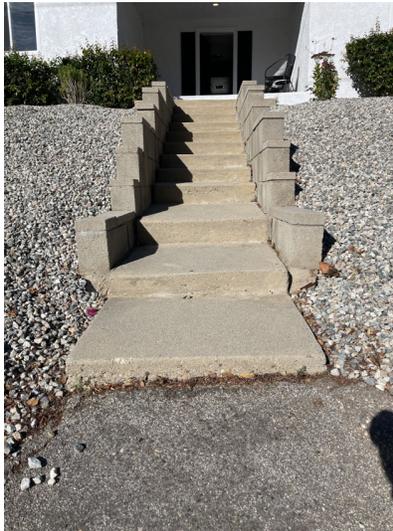
The risers of the stairs have uneven heights and may be a trip hazard.

The treads of the stairs have uneven measurements and may be a trip hazard.

risers / treads uneven

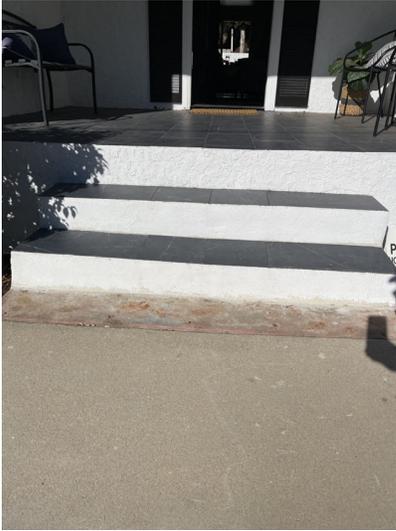
The risers of the steps up to the porch are uneven, and one step is too high. This could cause tripping hazards.

risers uneven / high step

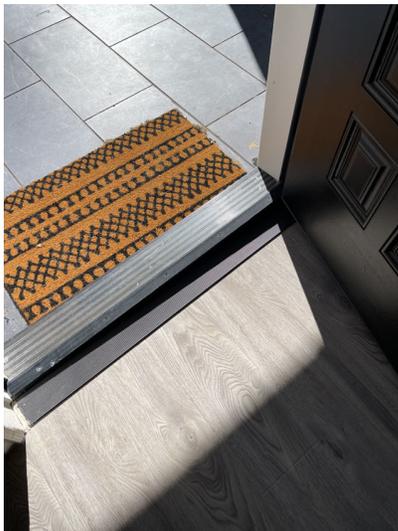
Threshold flexes: Front

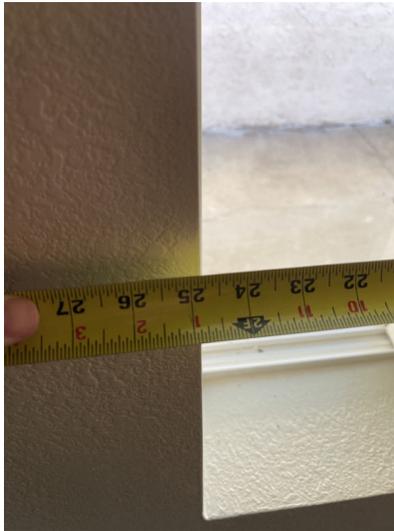
The windows in the bedroom at the rear, right corner of the home are not large enough for egress in case of fire.

too small for egress

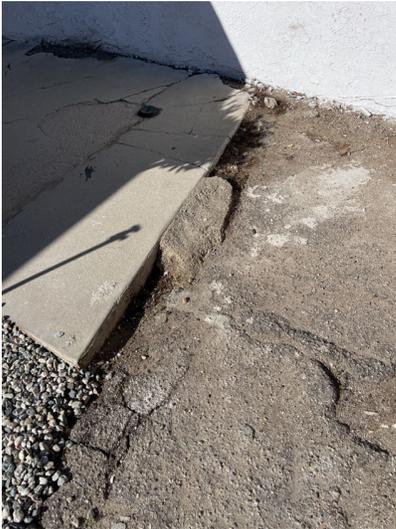
There are raised and shifted areas of the driveway that appear to be a trip hazard.

trip hazard

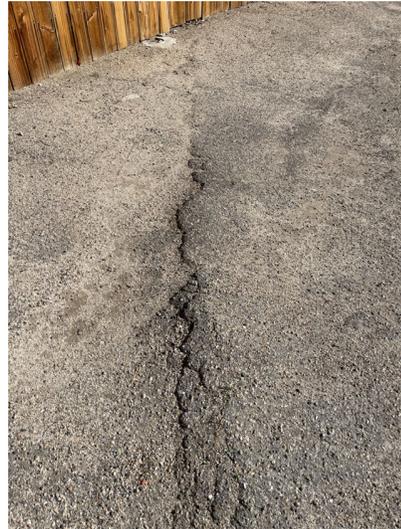
There are significant cracks and shifted areas of the driveway.

large cracks

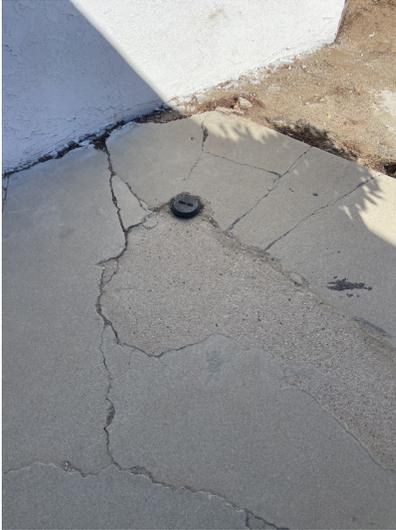
large cracks / shifting

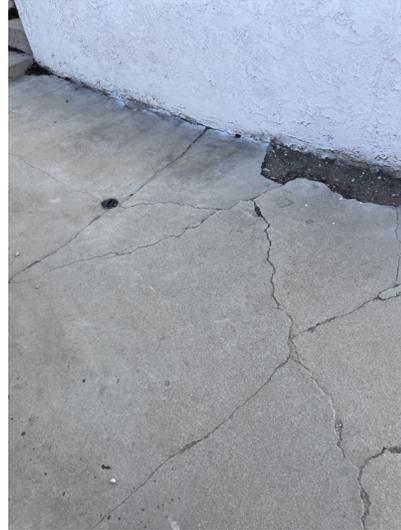
Large cracks / shifting

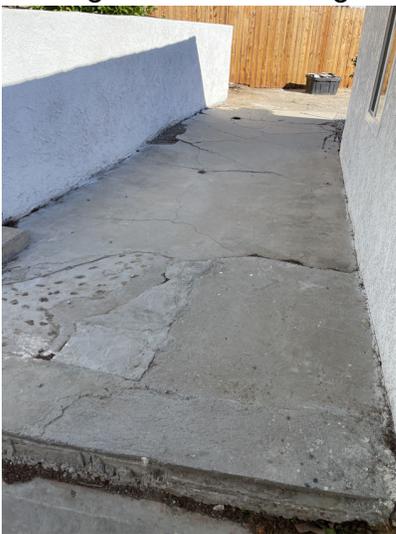
large crack / shifting

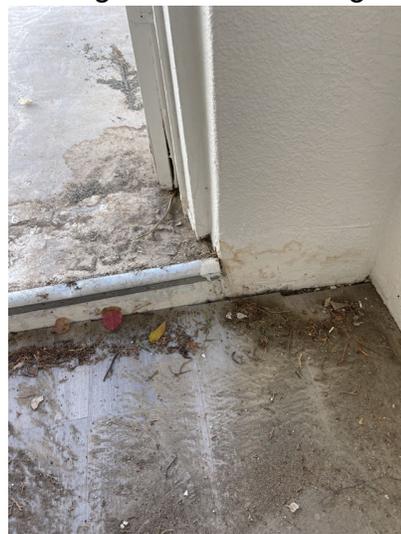
The patio is not correctly sloped to provide proper drainage away from the house.

The back patio area is sloped in such a way that any water runoff would go into the exterior room that the water heater is being kept in.

staining from sloping towards house

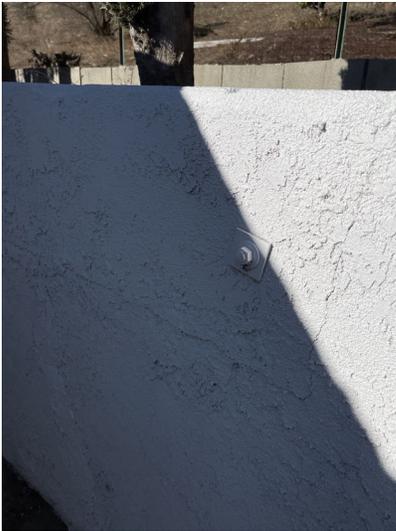
past repairs

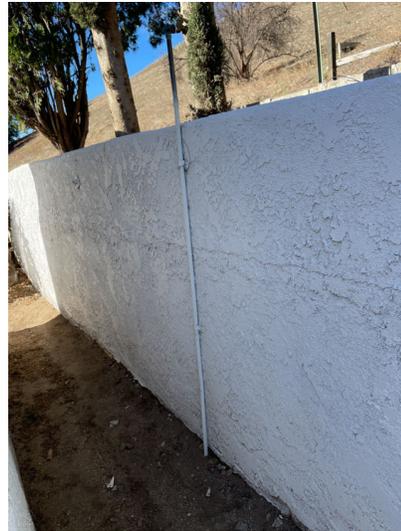
cracking

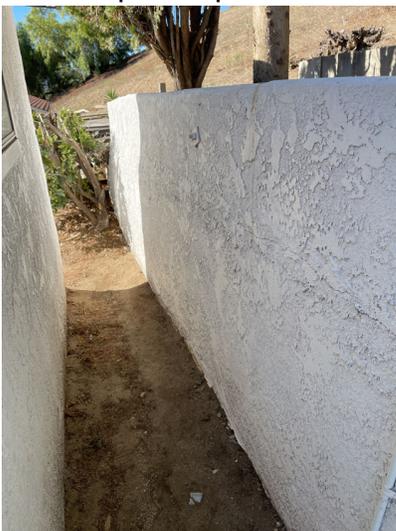
The concrete blocks used on the rear left retaining wall are too small for this area. You can see there are areas that are being affected by hydrostatic pressure due to the lack of weep holes. The lower part of the wall is bulging out. There has also been repairs made to attempt to strengthen this wall and there is a large crack going around these areas of repair as the rest of the wall is moving in the small area that was fixed is not.

Bulging

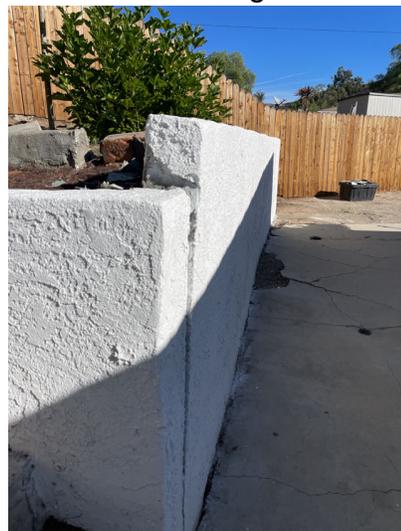
cracked / leaning

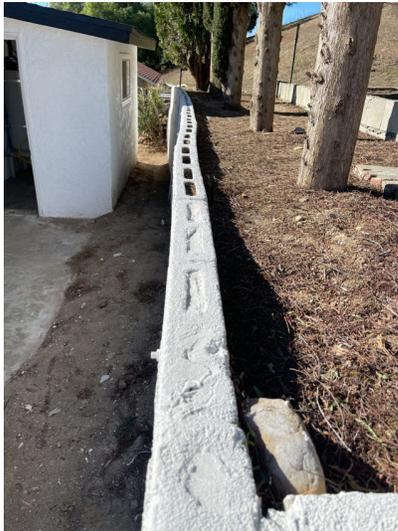
blocks used too small

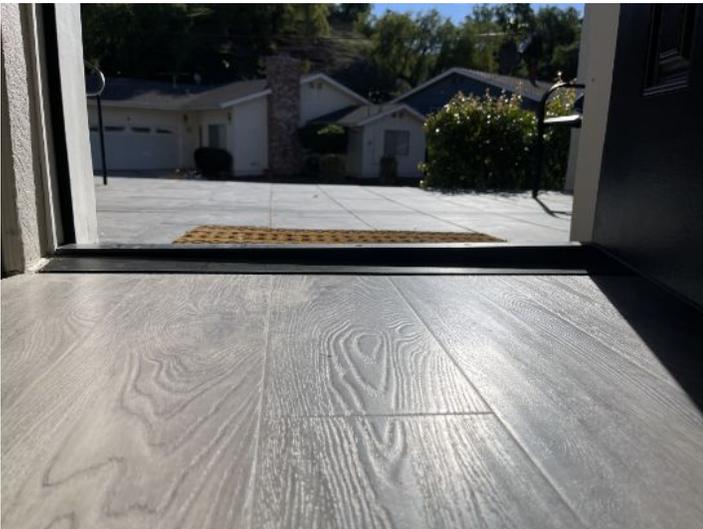
There are areas where the flooring is sloping and not level. Please refer to the foundation section for more info.

sloping can be seen, threshold height is less on the left and more on the right. about a 1/2 in difference.

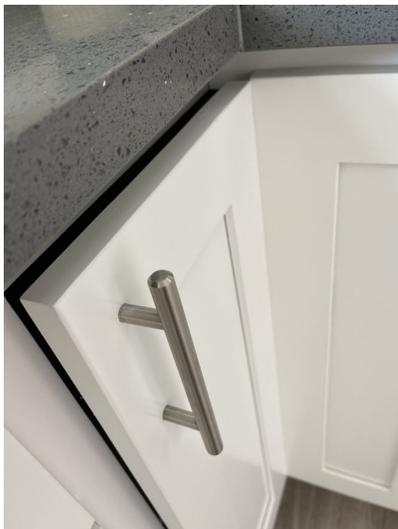
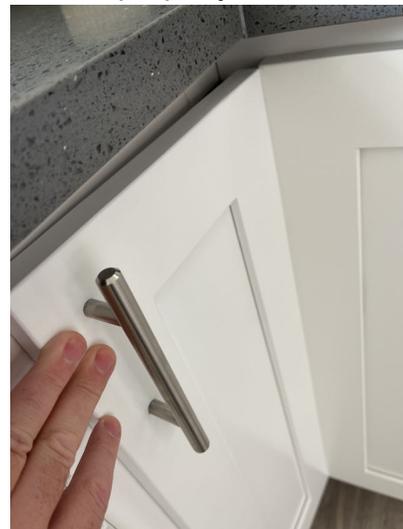
The corner cabinet of the lower section has a door that will not close properly.

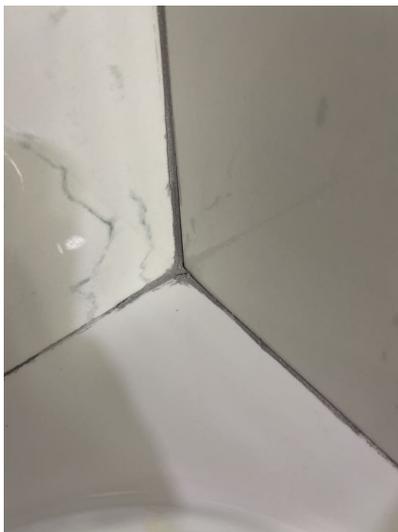
The seal at the tub/tile connection is deteriorated.

Tub/tile connection deteriorated

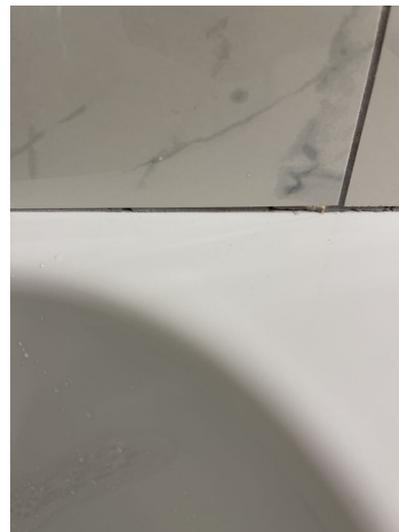
Tub/tile connection deteriorated

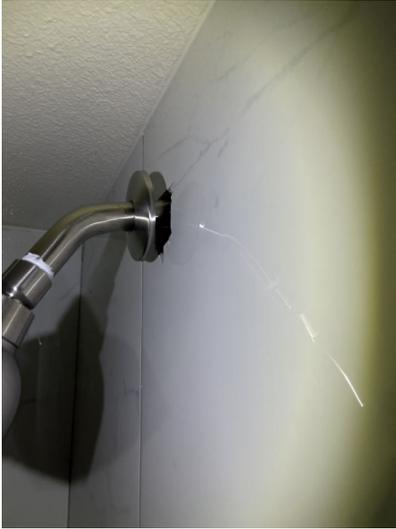
The trim is not sealed to the wall properly.

Wall trim gap

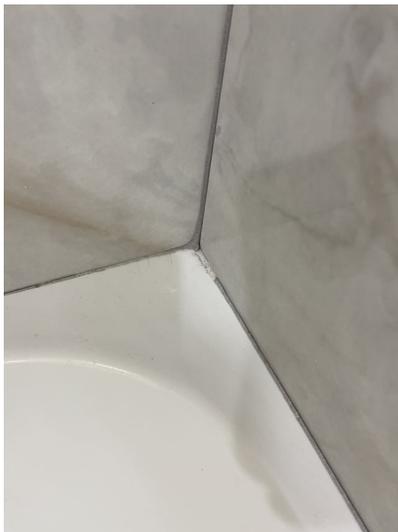
The seal at the tub/tile connection is deteriorated.

Tub/tile connection deteriorated

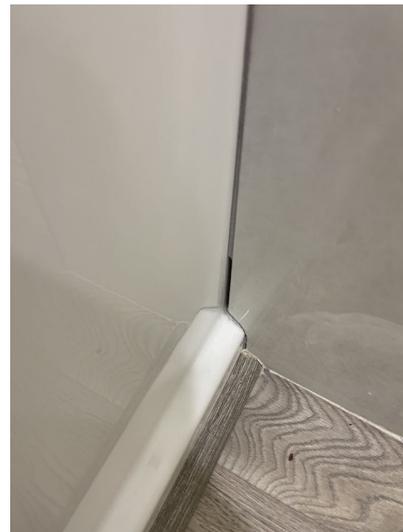
Tub/tile connection deteriorated

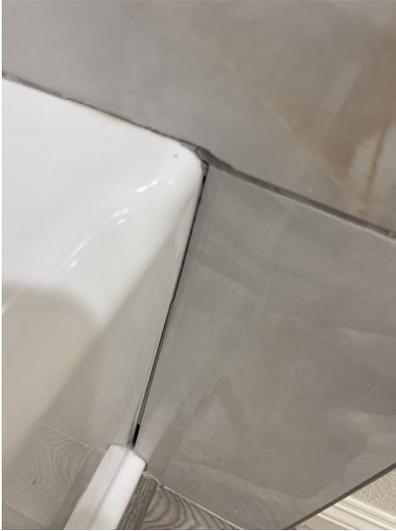
Tub/tile connection deteriorated

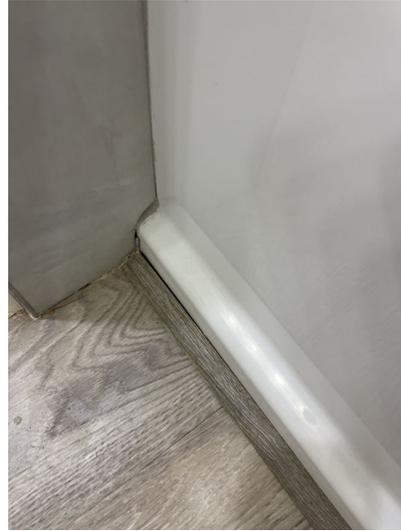
Tub/tile connection deteriorated
