# PROPERTY INSPECTION REPORT

**246 Second St, Your Town, CA, 91355**

**Inspector: Garrett Martell CMI**

**Date of Inspection: 10/25/2022**

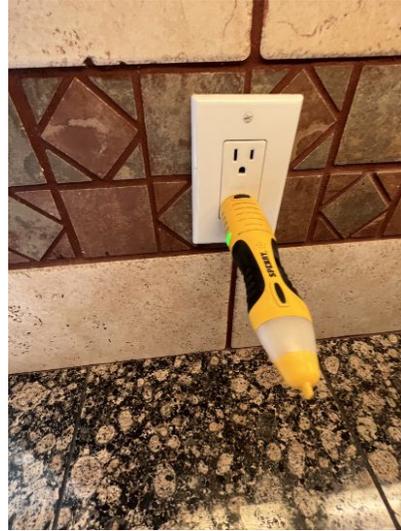
Kitchen - No GFCI

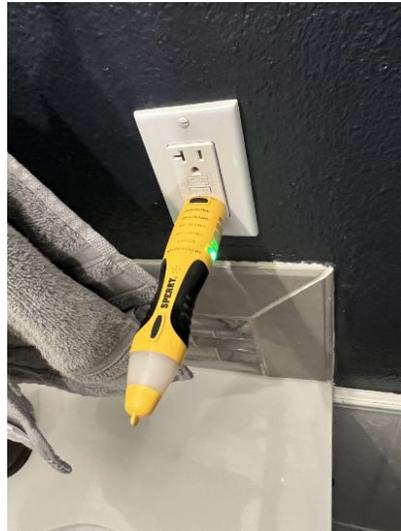
**GFCI in bathroom1 did not reset properly.**

Bathroom 1 - GFCI did not reset

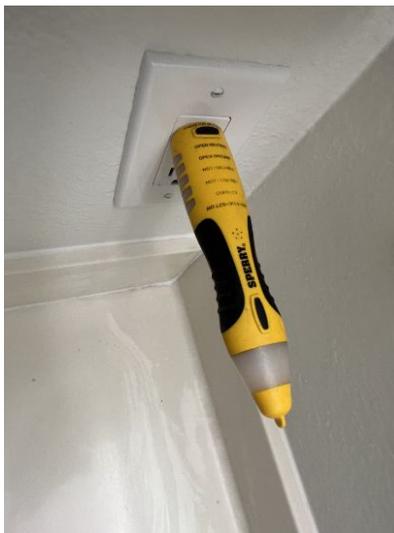
**There is one or more outlets that have no power to them and are not working in areas of the home - master bathroom.**

Master bathroom -

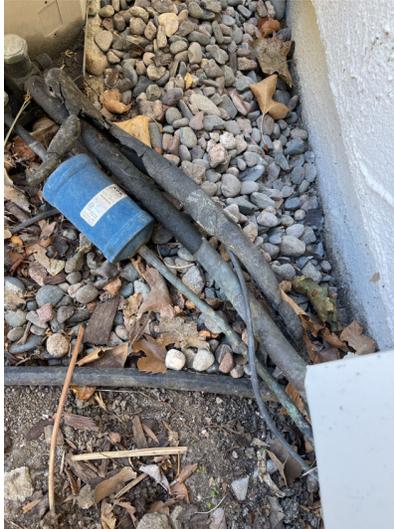
There is no condensate drain pan installed. The condensate drain pan catches excess water that did not make it into the condensate line or, the overflow if the condensate lines stop working properly. It also makes sure the water is safely disposed of outside the home.

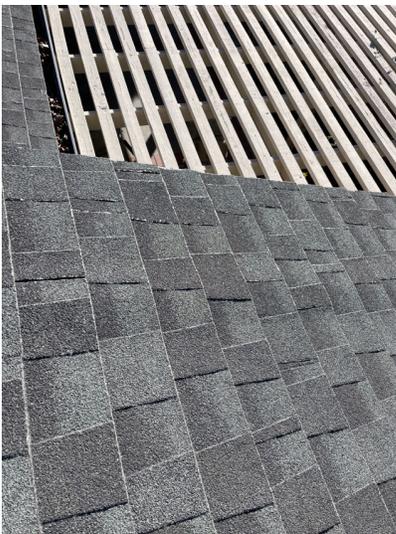
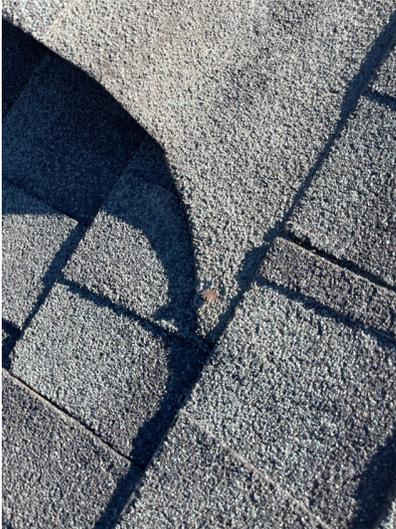
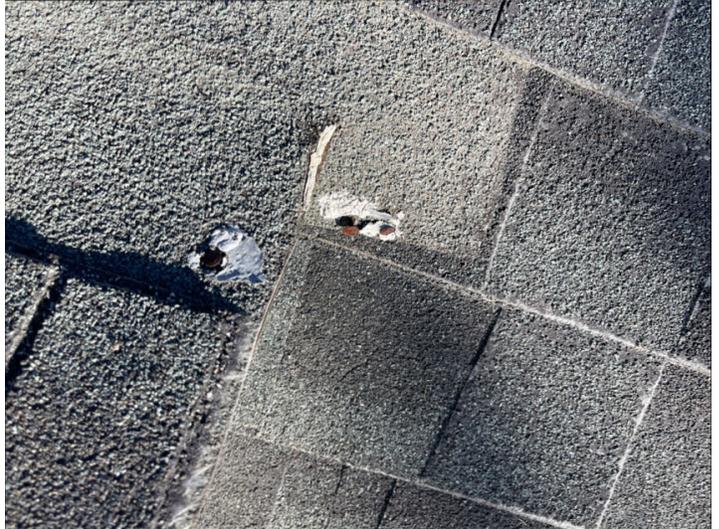
**Notable deterioration was found in areas across the roof covering that may be wind related**

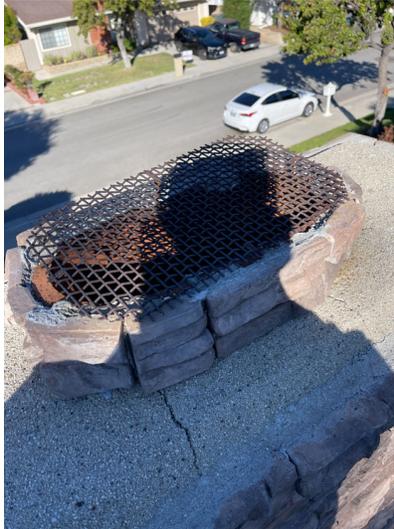
The chimney has screen on it as a spark arrestor. This is non-standard as the screens do not prevent water intrusion, and they may clog. There needs to be a proper weather proof spark arrestor installed as per current standards.

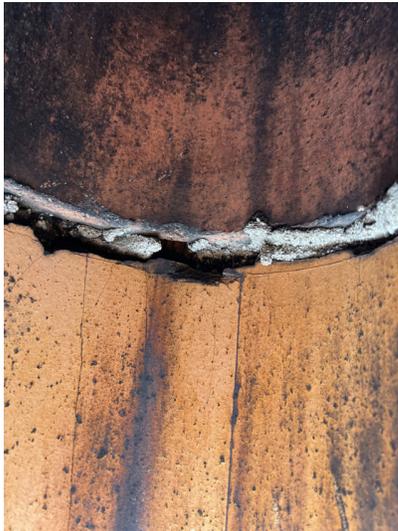
**There are some offsets and gapping in the mortar that could be seen, looking down the flue from the top portion.**

gaping in the mortar

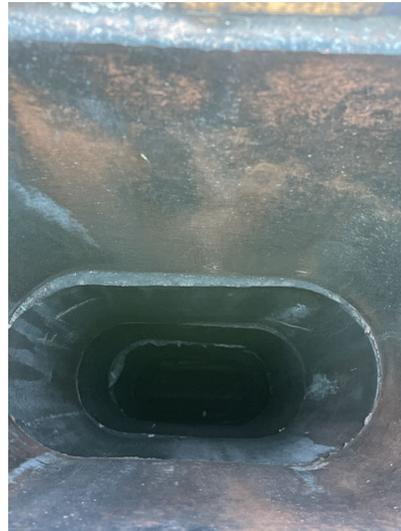
offsets

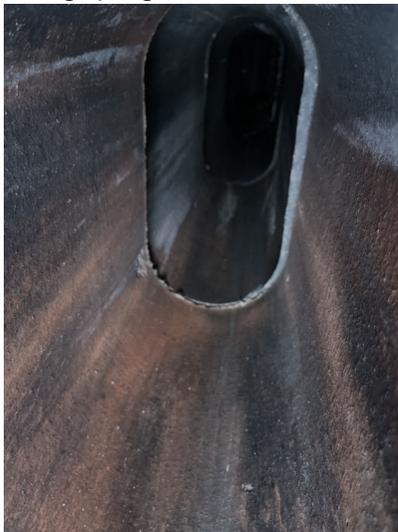
offsets

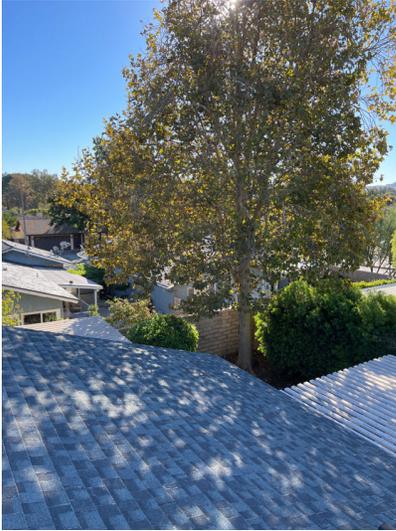
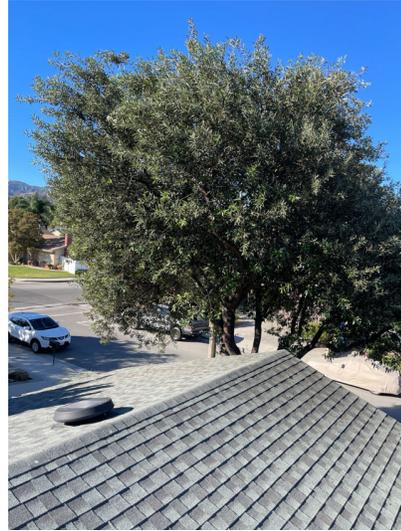
## Landscaping

There are trees planted close to the structure with branches that are overhanging/close to the roof. These may need to be trimmed back at times.

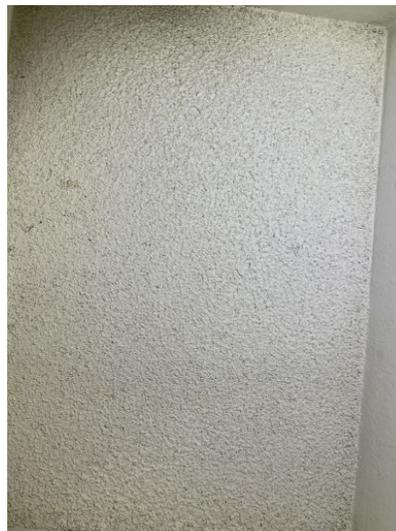
There is a cutout in the wall with wires in it. This should be capped with a coverplate.

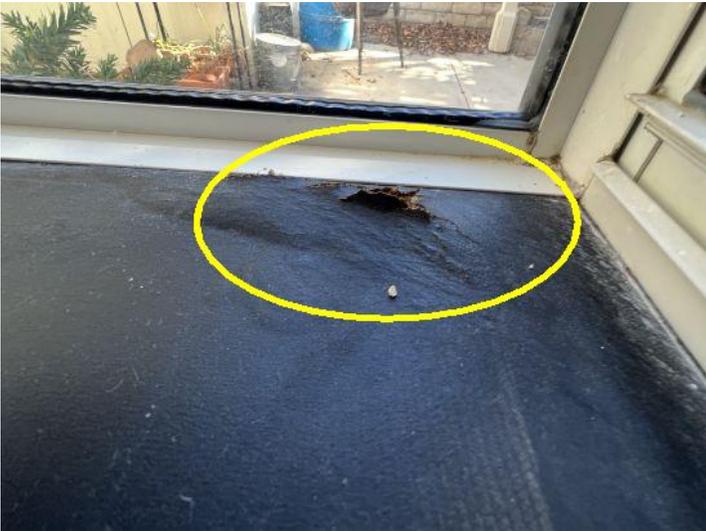
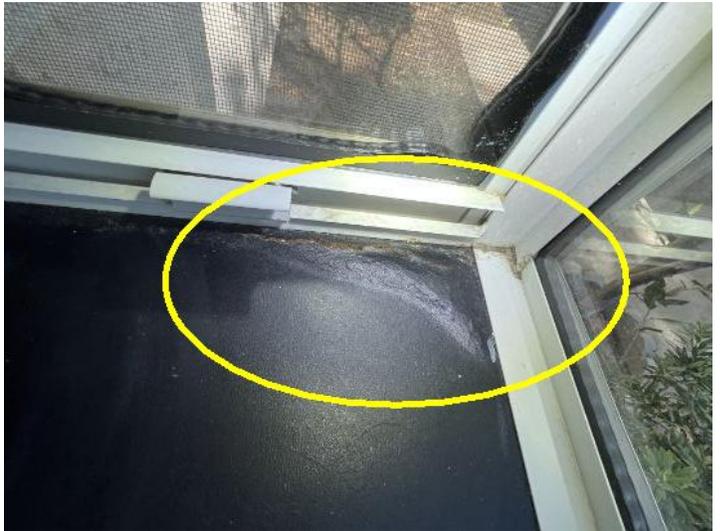
In a back bedroom, there is moisture damage in the floor bottom of the bay window.

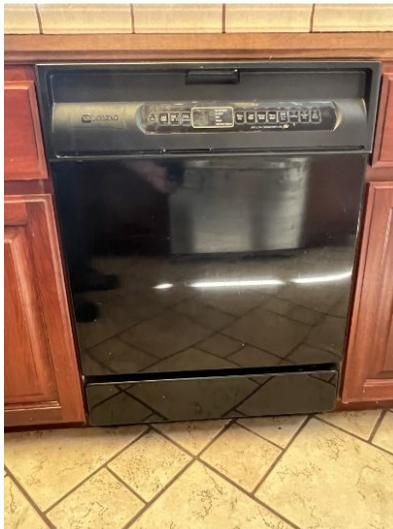
## Dishwasher

The dishwasher is an older model appliance.
