PROPERTY INSPECTION REPORT

123 Anywhere St, My Town, CA,

Inspector: Garrett Martell CMI

Date of Inspection: 11/26/2022

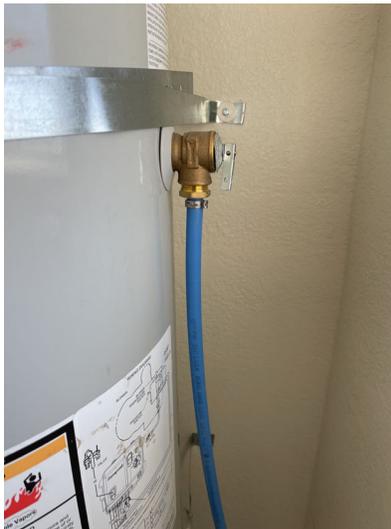
The TPR/Drain line has been incorrectly installed.

The drain line was reduced in size from the opening size at the **TPR valve**. This needs to be corrected for proper operation.

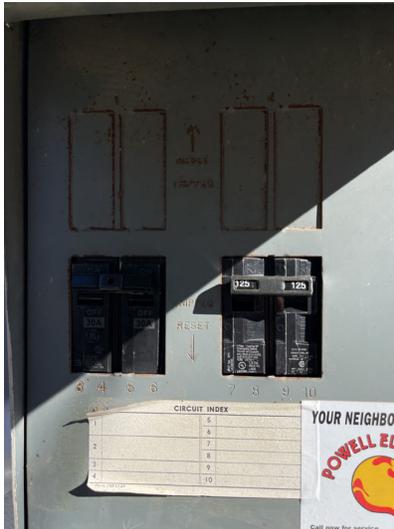
There is a second 30 amp breaker inside the main panel. Is unknown with this goes through as there is no labeling.

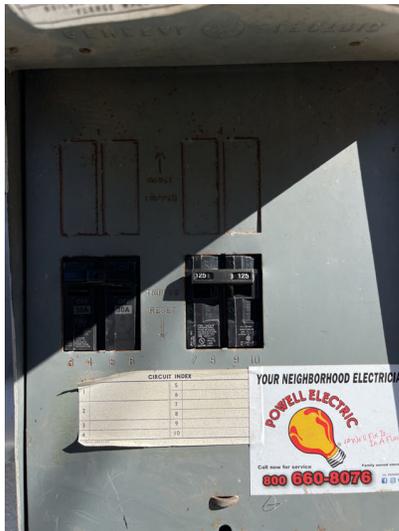
The circuit breakers in the main electric panel are not labeled. It is not known which circuit goes with which breaker. This could pose a problem in case there is an emergency reason comes up to shut off power to a specific area of the home.

no labels

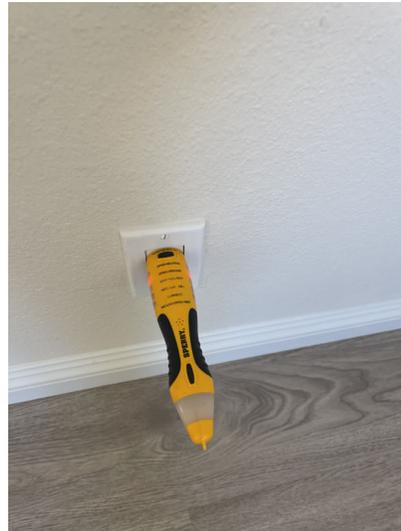
3 prong ungrounded outlet back right bedroom

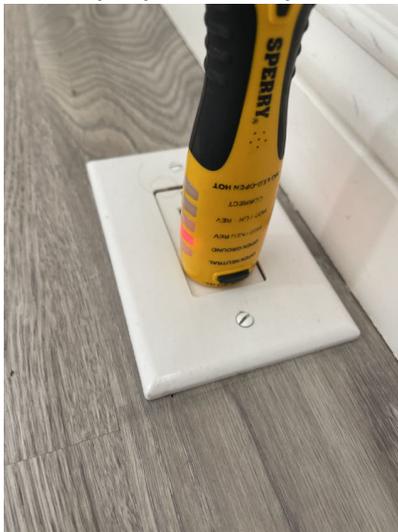
3 prong ungrounded outlet back right bedroom

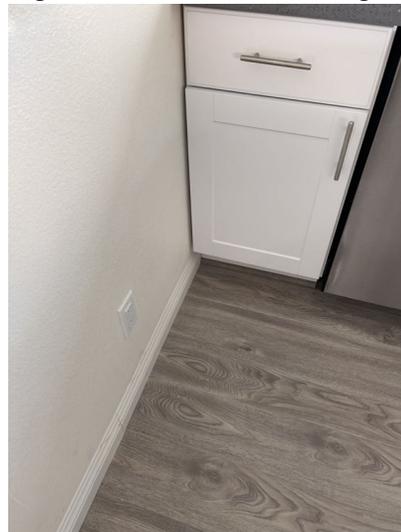
No GFCI in the Kitchen

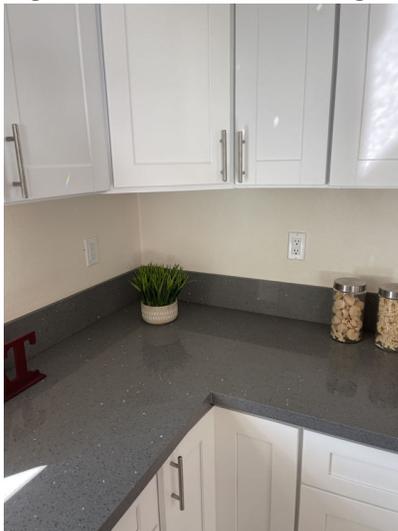
No GFCI in the Kitchen

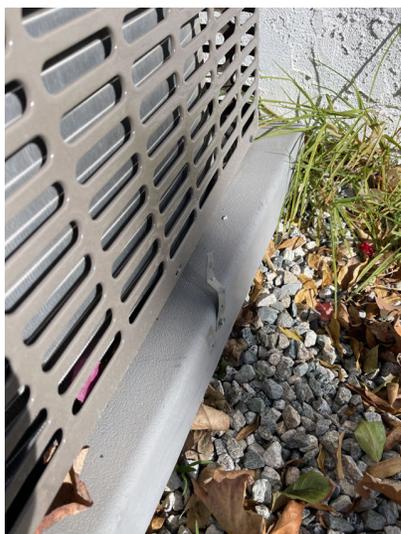
The condenser has not been anchored properly. This needs to be properly secured.

Not anchored properly

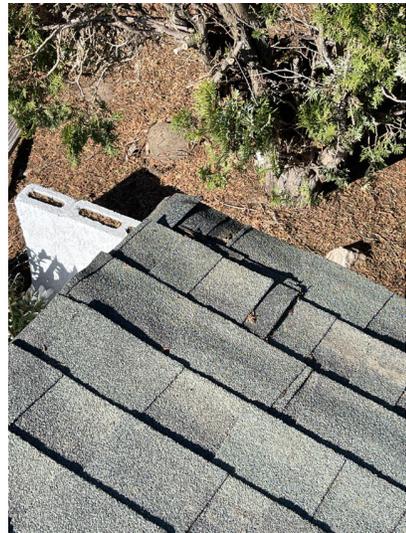
patching

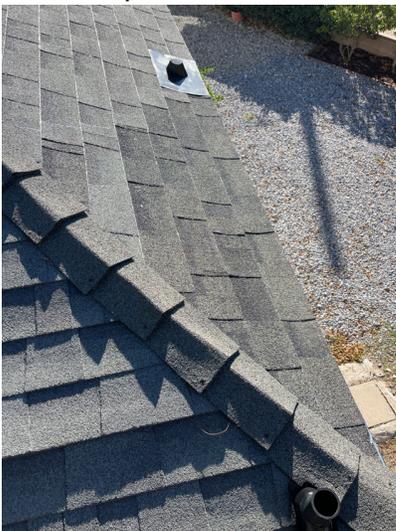
ridge caps old

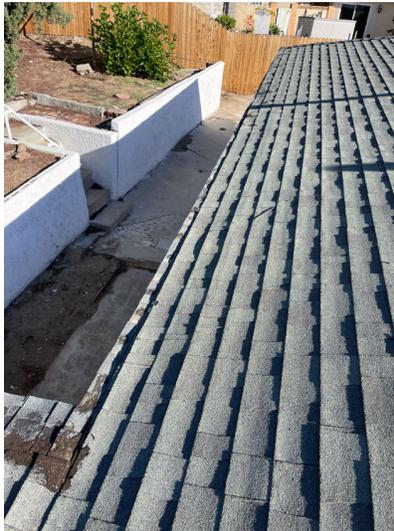
civered mastic / roof patching

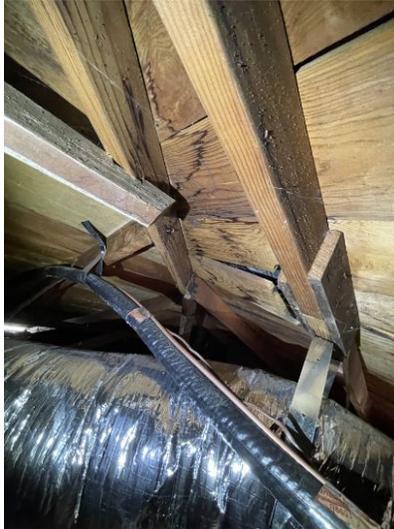
Moisture staining

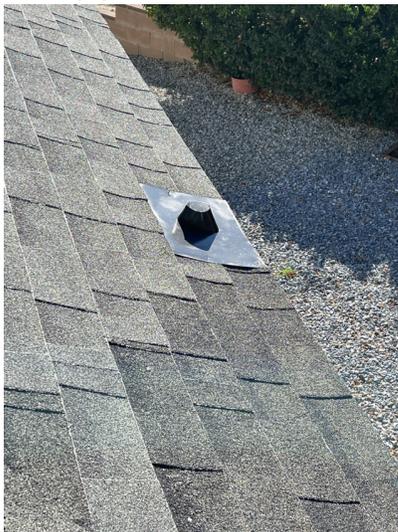
There are vent pipes that are too low and do not extend high enough above the roof.

short vent

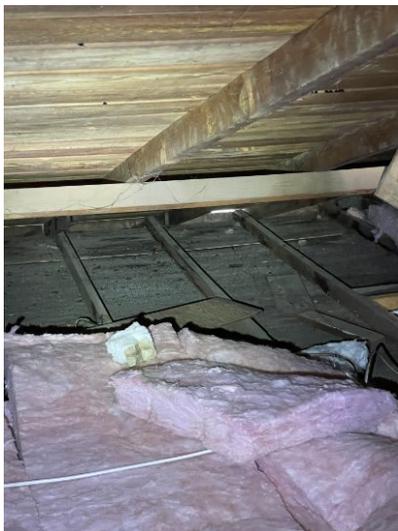
The insulation has been disturbed and good coverage is no longer present in some areas of the attic. Ideally, there would be 8-12 inches of insulation in the attic for improved energy efficiency of the home.

Disturbed insulation

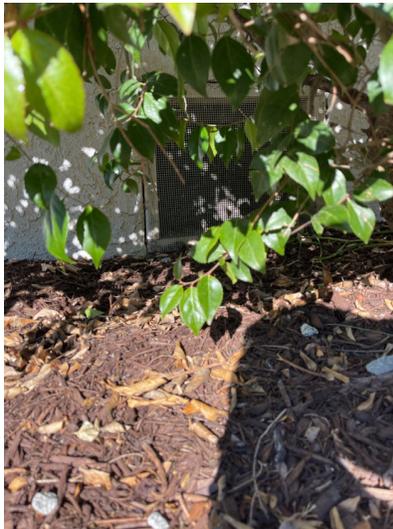
The crawl space access is located in an area that makes it difficult to use.

difficult to access

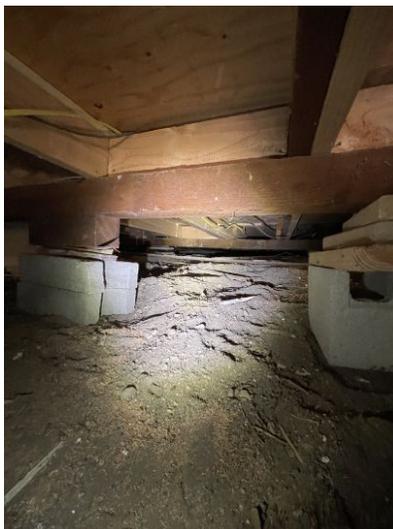
The crawl space was not tall enough to enter in areas, 18 inches of space is required for safe access.

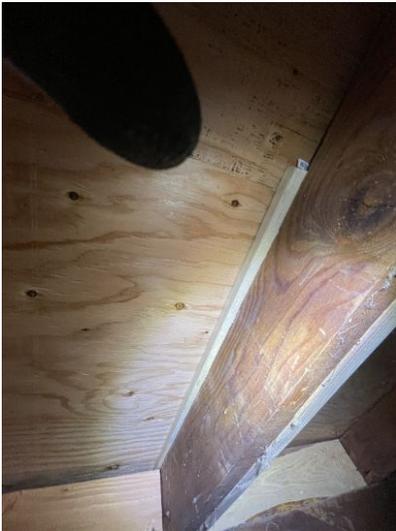
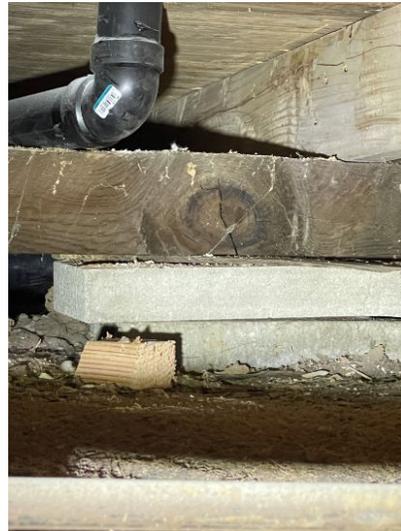
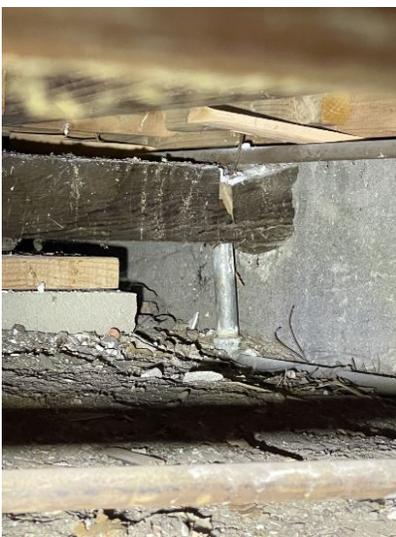
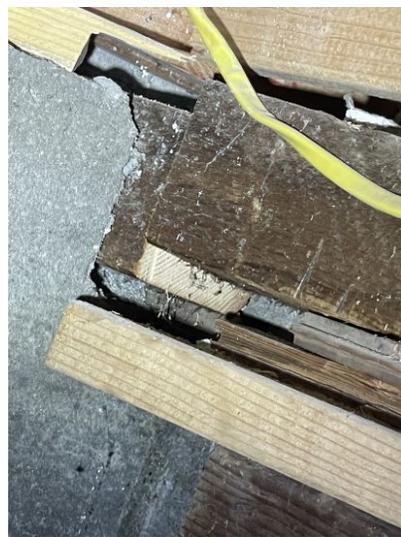
A number of pieces of wood such as shims are being used in place of a single support post in areas. These tend to fall out during seismic activity and are not properly attached to each other or the framing of the structure.

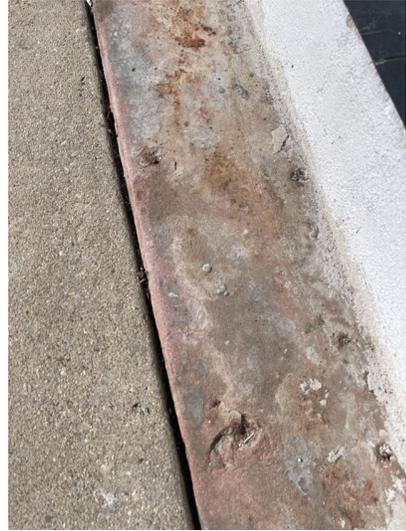
rebar exposed

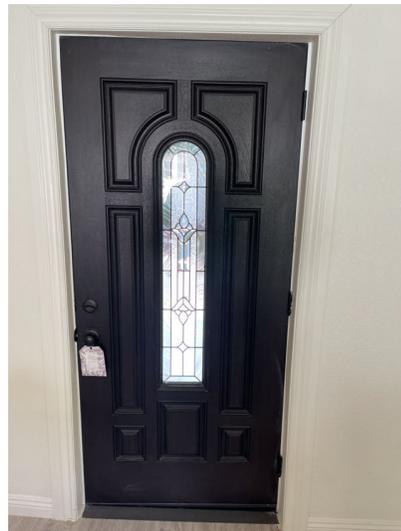
crooked

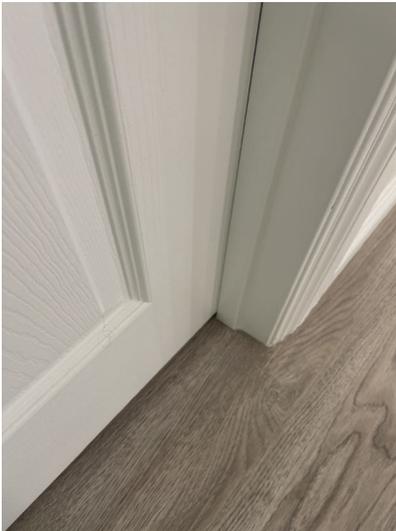
The interior door going into the laundry room appears to not been installed properly. There are gaps on the inside of the door when the door is closed. It is very out of square. The last few inches of the clothes are difficult as the bottom of the door is hitting the frame, causing there to be a spring lake action wants the door is unlatched.

frame hits

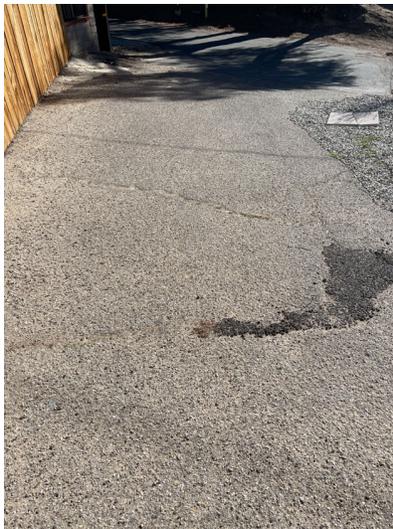
typical cracking

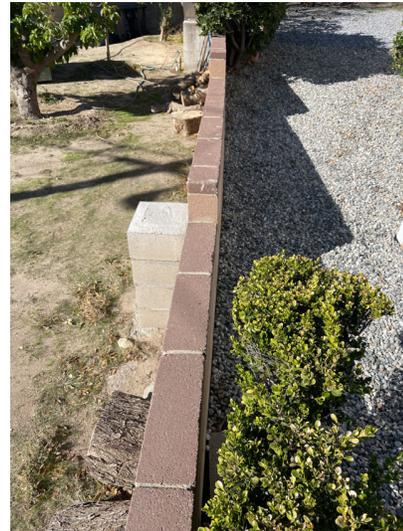
The concrete blocks used on the rear left retaining wall are too small for this area. You can see there are areas that are being affected by hydrostatic pressure due to the lack of weep holes. The lower part of the wall is bulging out. There has also been repairs made to attempt to strengthen this wall and there is a large crack going around these areas of repair as the rest of the wall is moving in the small area that was fixed is not.

blocks too small

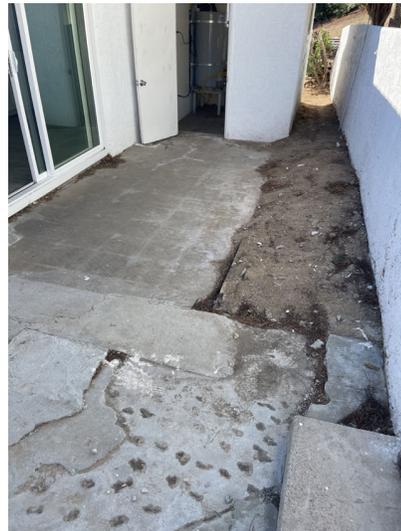
The landscaping at the rear and right side and the left side slopes toward the structural foundation in areas. This can cause over-saturation of the soil at the structural footings which is one of the main causes of foundation settlement. Slope should fall away from the foundation at a minimum of 1/4 inch per foot and extend at least 10 feet away from the foundation.

slopes toward house

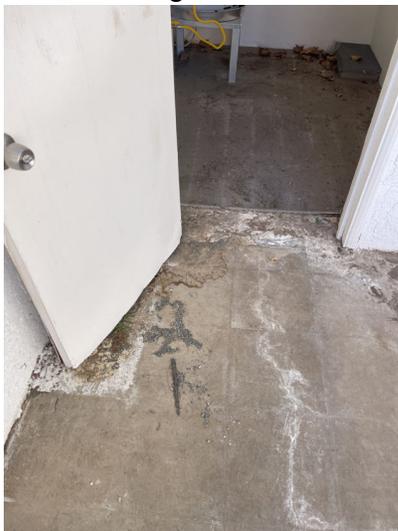
There is evidence of improper drainage on the site in areas. The site is a relatively flat site, it is expected that there will be some areas where water will pool during rainy periods.

ponding / slopes toward house

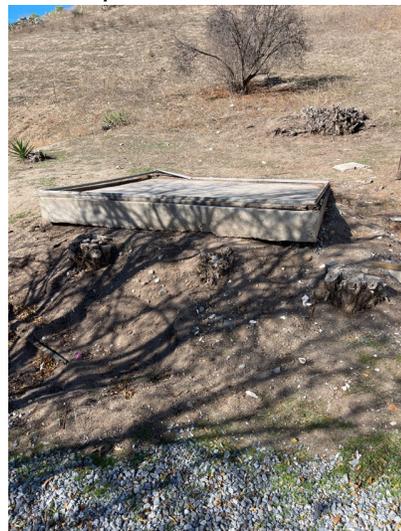
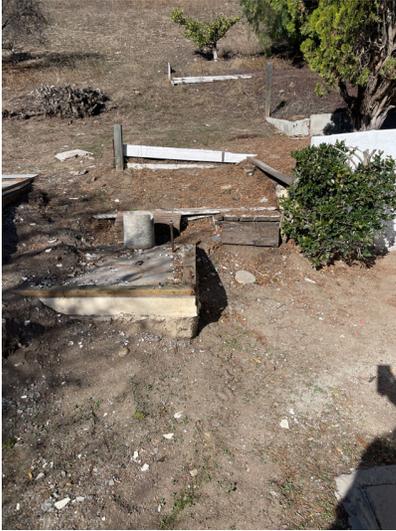
There is evidence of improper drainage on the site causing erosion of the soil in areas.

Soil erosion: Rear, Left

It is advisable to have a Geologist fully examine the site and make any recommendation concerning erosion and drainage.

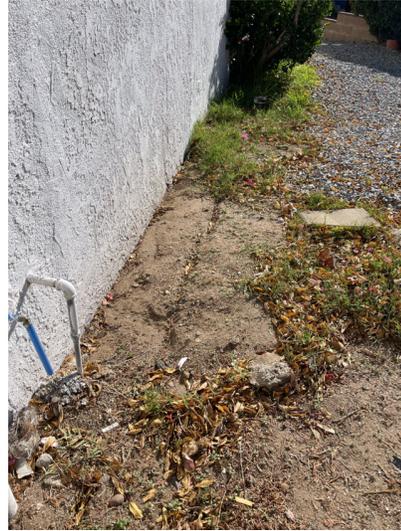
slopes towards house

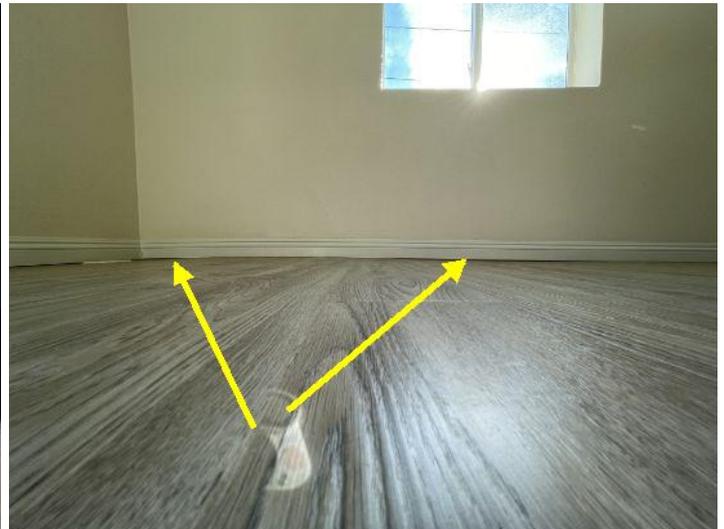
There are areas where the flooring is sloping and not level. Please refer to the foundation section for more info.

sloping seen from the gaps on the left and right of the baseboard

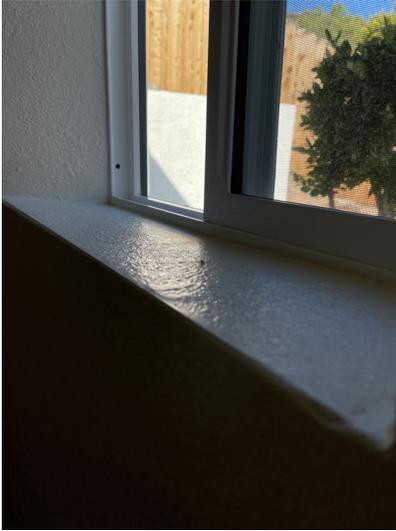
sloping sill

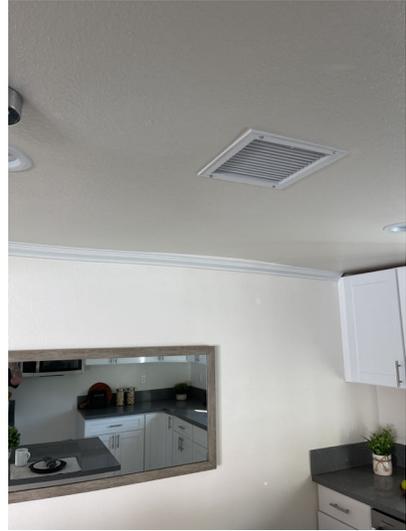
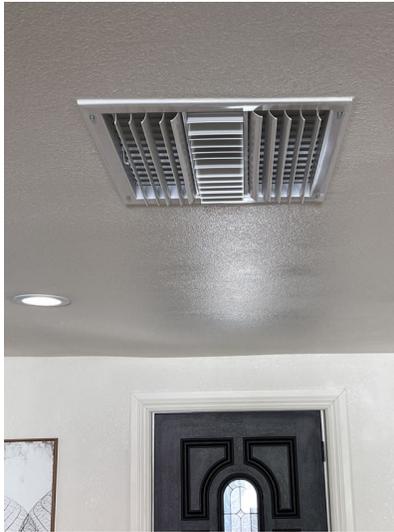
Besides the floor, there is notable sloping at the ceiling in areas.

uneven ceilings

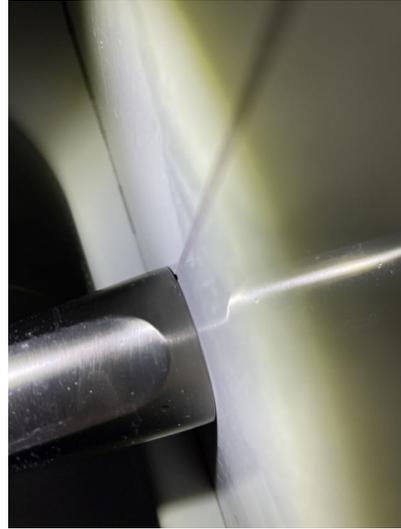
Wall trim gap

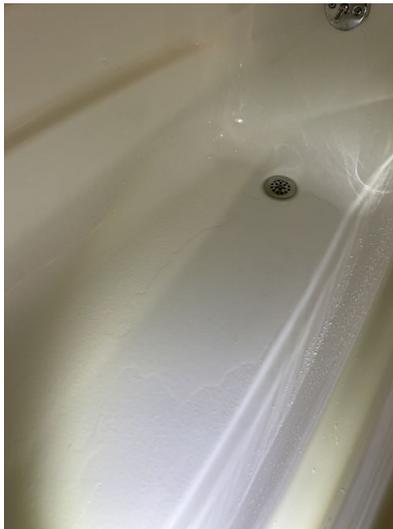
Due to the extreme sloping of the home, the bathtub in the master bathroom does not appear to be sloped correctly to allow 100% of the water to drain from the tub.

does not fully drain

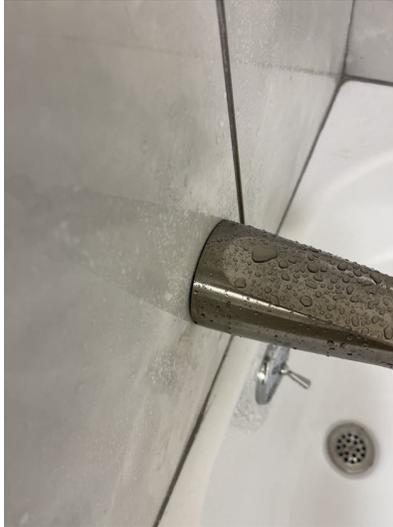
The trim is not sealed to the wall properly.

Wall trim gap
